Local Structure Plan Lot 34 Third Street, Harvey

(August 2019)
Ref: 17-05-VER

Prepared For
Mr B. Versaci
&
The Shire of Harvey

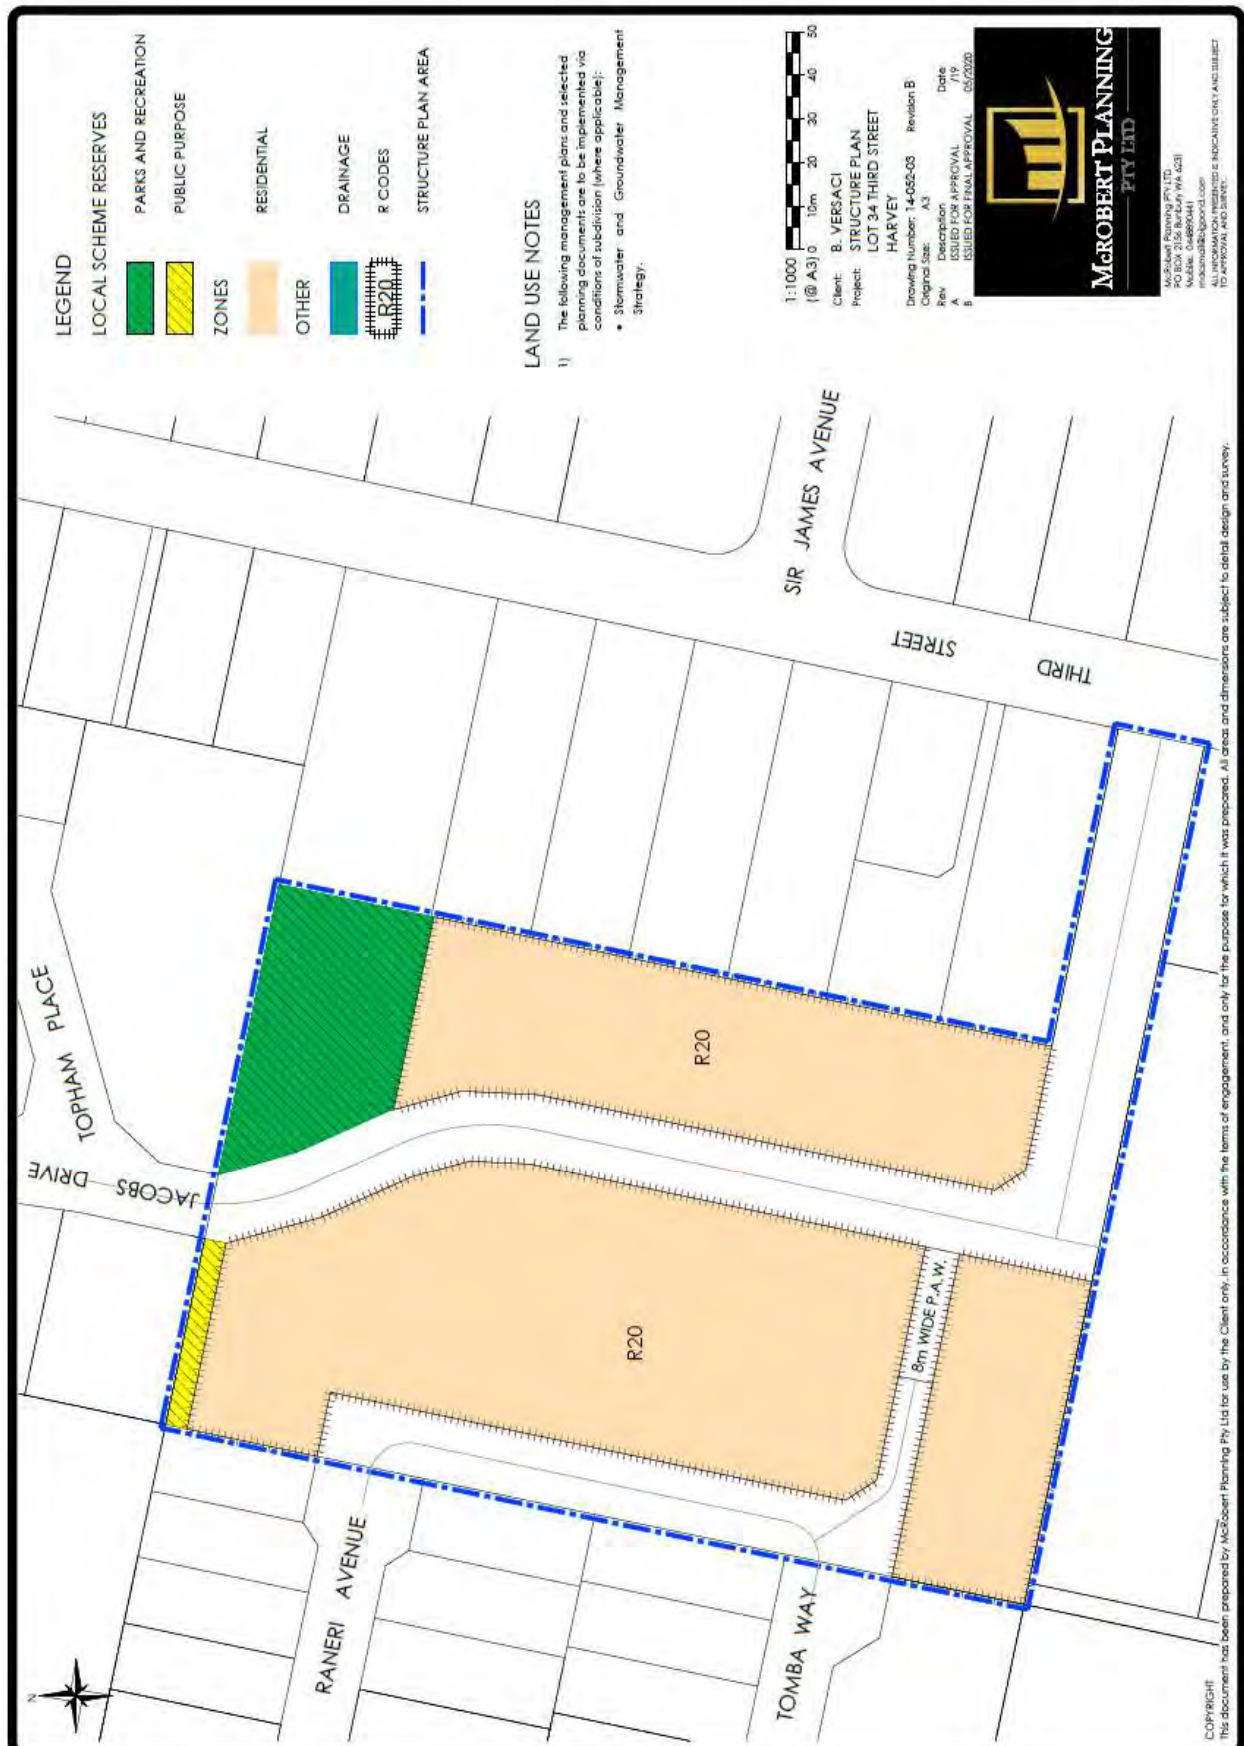
Figure 3
Lot 34 Third Street Local Structure Plan

The Structure Plan area is highlighted by a blue line in **Figure 3** and **Attachment 1**.

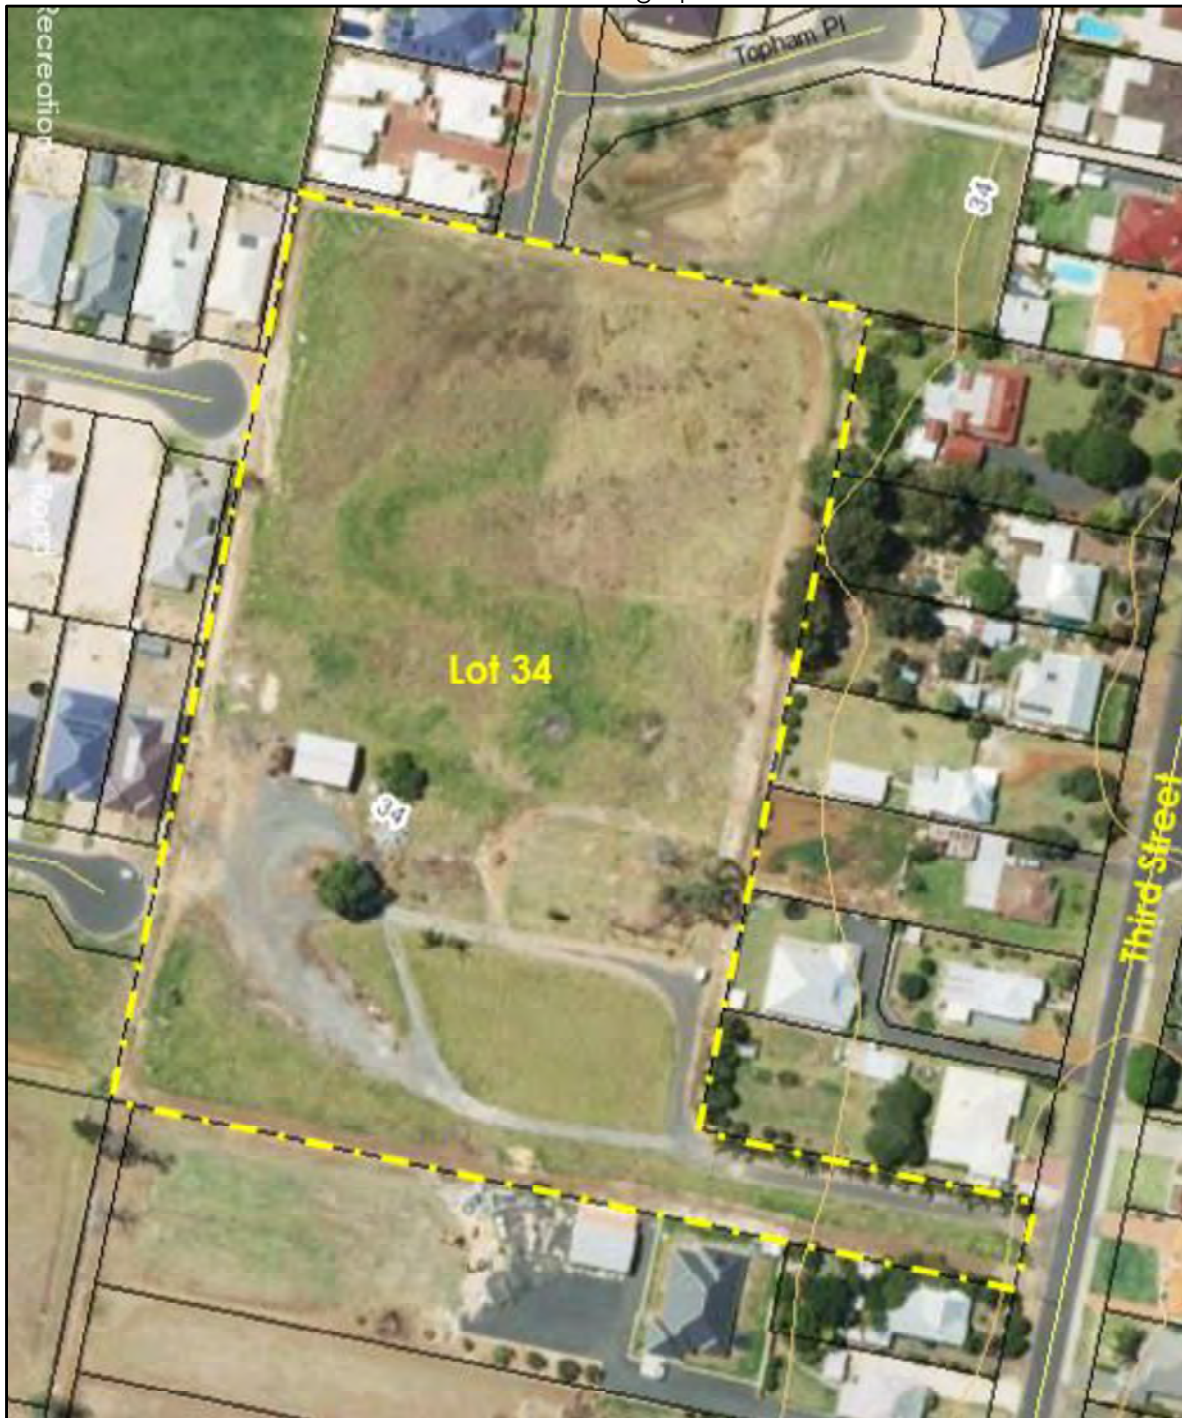
Figure 5
Aerial Photograph

Much of the subject land, due to its previous rural use, is generally cleared with some intermittent trees. **Figure 5** depicts the predominantly cleared nature of the land. It should be noted that the shed that appears on the land within Figure 5 has been removed.

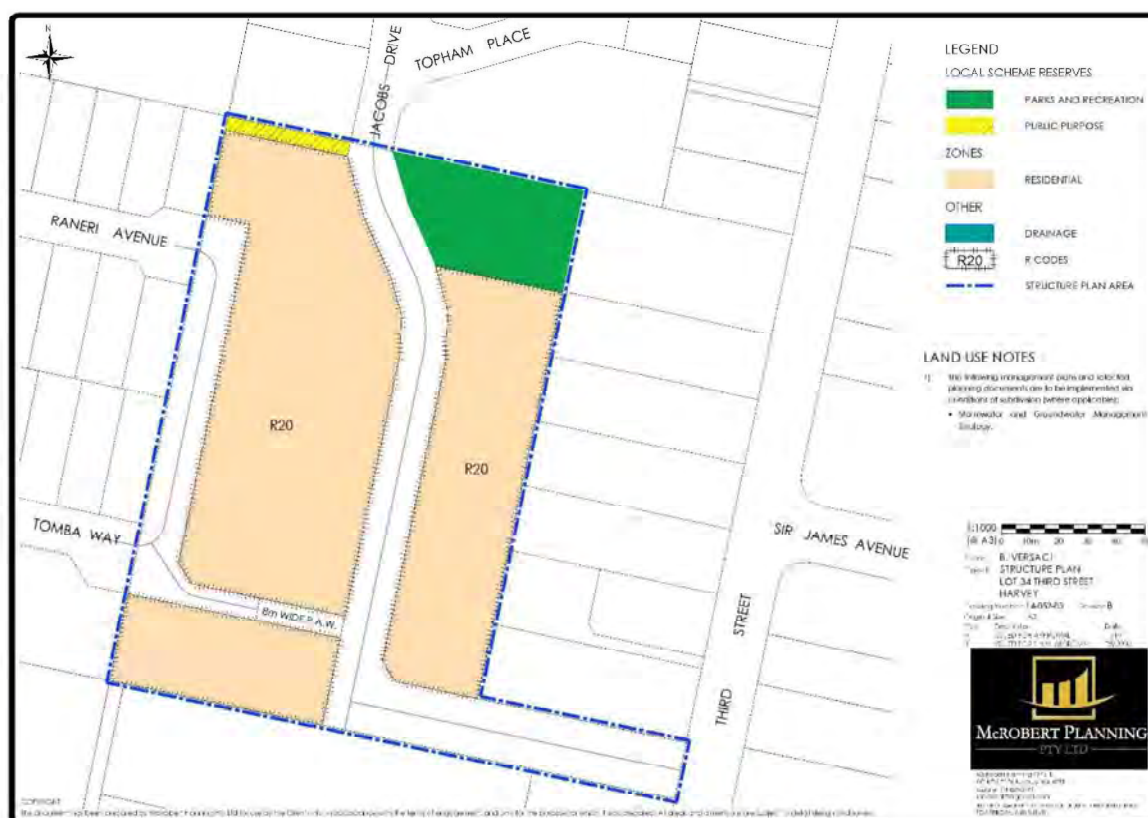
Figure 3
Amended Structure Plan

The proposed Structure Plan as lodged by McRobert Planning for approval was requested to be amended in May 2020 by the Western Australian Planning Commission (WAPC), this has resulted in the need to create revision 3 of this Stormwater and Groundwater Management Plan. The amended Structure Plan including the requested amendments by the WAPC is shown below, with an A3 version included as Attachment 1.

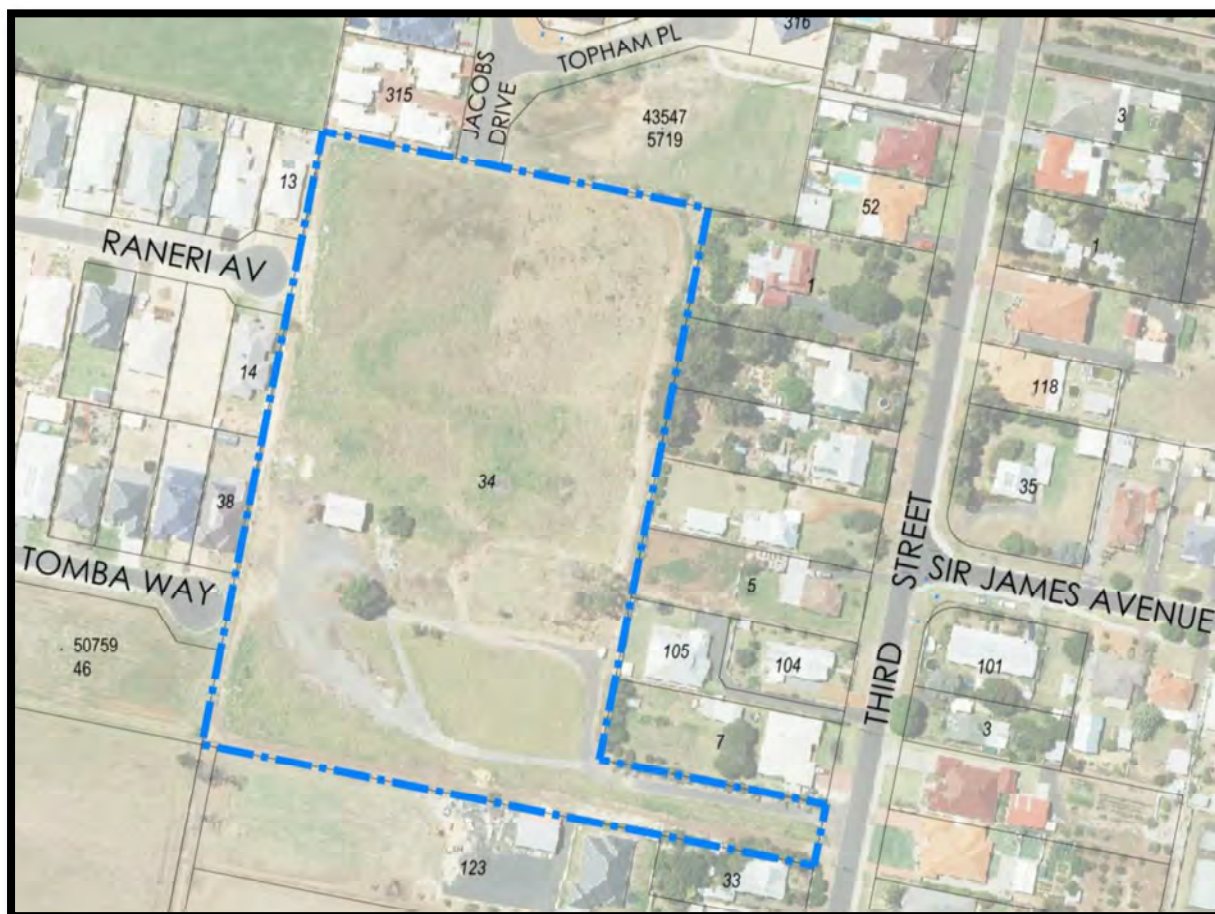
Figure 4
Aerial Photograph with Cadastral Overlay

The following aerial photograph with cadastral overlay (refer to Figure 4) depicts the predominantly cleared nature of the land.

As can be noted from the aerial photograph the site is largely devoid of extensive vegetation. The use of the property for general farming and storage has resulted in the larger vegetation being removed.

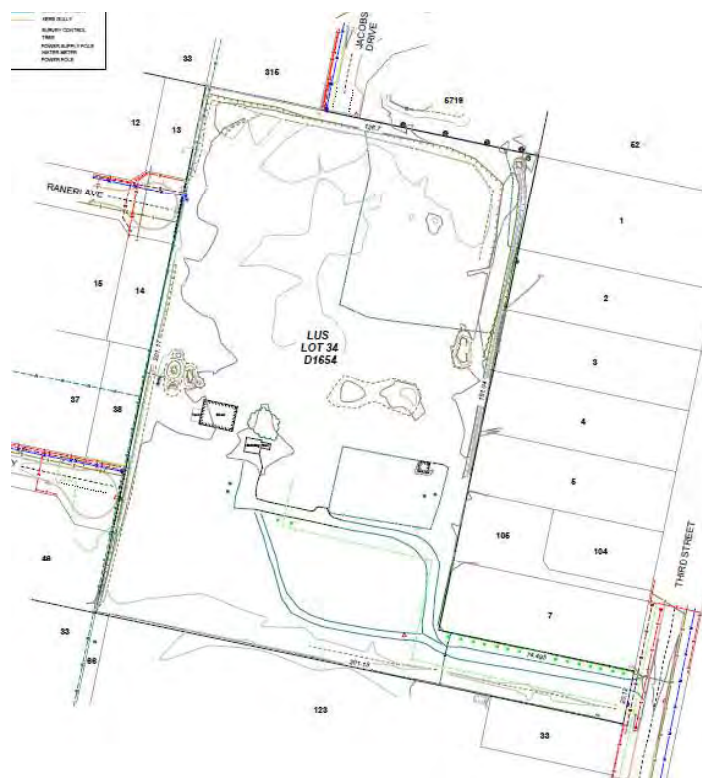
Figure 6
Topography

The structure plan area is best described as relatively flat with levels ranging from RL 34 metres AHD to RL 34.5 metres AHD. A copy of the feature survey plan is included below, as Figure 6 and included in A3 size as Attachment 3.

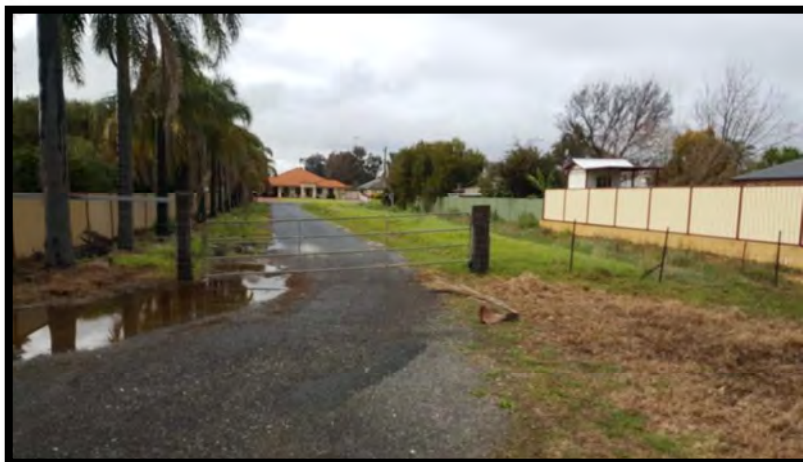
Figure 7

A visual representation of the sites surface water hydrology is included below as a series of photographs taken of the site in August 2016, following and during a rain event.

Property Picture (looking east, from site towards Third Street)

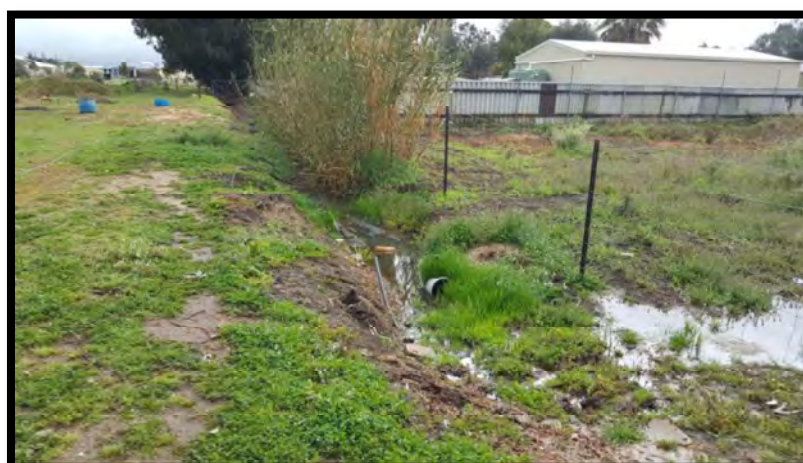
Figure 8

Property Picture (looking north along eastern boundary)

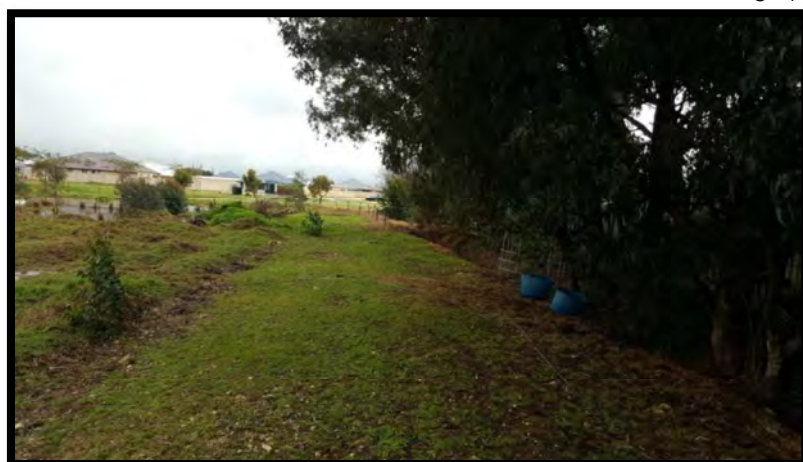
Figure 9

Property Picture (looking north at the northern end of existing drain to east boundary)

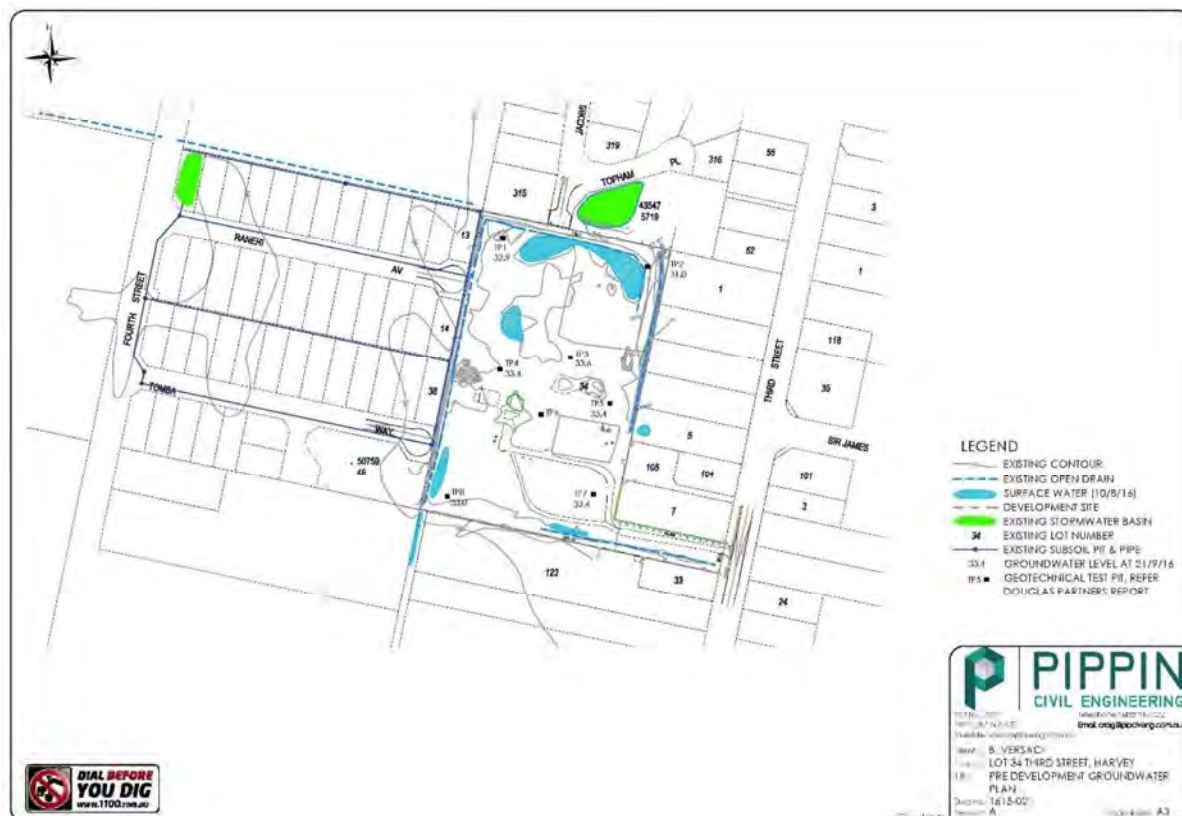
The geotechnical investigation was completed on the 21st September 2016. The investigation included the excavation of 8 test pits across the entire site, of which all but 1 pit noted groundwater seepage. A plan of the test pits locations is included on the Predevelopment Groundwater Plan as included below as Figure 14 and within Attachment 6.

As can be noted from the Predevelopment Groundwater Plan the existing groundwater surface profile varies from 0.6m to in excess of 2.0m deep, however surface water ponding occurs in several areas across the development site and covers an extensive area along the northern boundary.

Predevelopment Groundwater Plan

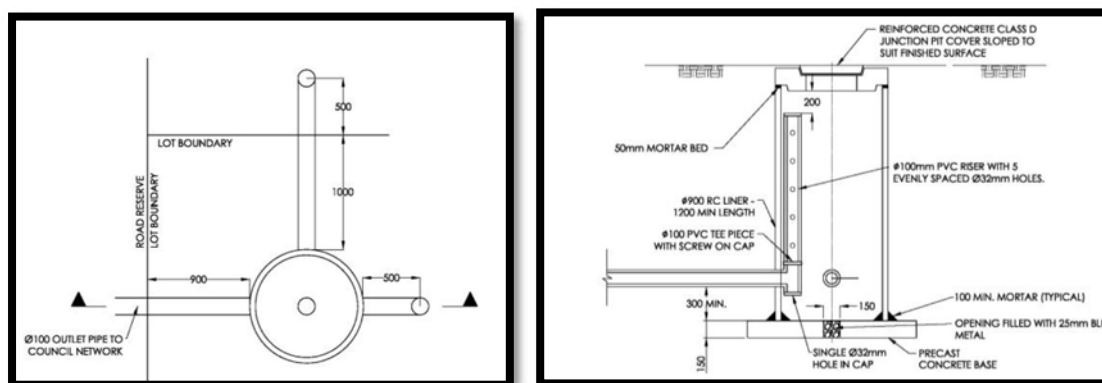
Figure 15 Lot Connection Pit – Plan and Cross Section

This development proposes to construct the connections from each lot to what will become the Shire's pit and pipe network within the road reserve, as part of the subdivision process. In addition, due to the removal of the existing open swale to the eastern property boundary the development proposes to install a lot connection pit in the rear of the existing lots fronting Third St. This will ensure that the drainage catchment that currently connects to this open drain remains the same in the post development strategy, as the drain will be filled in with development. An indicative plan for a shared property connection 'silt trap' pit for two lots, is shown below as Figure 15.

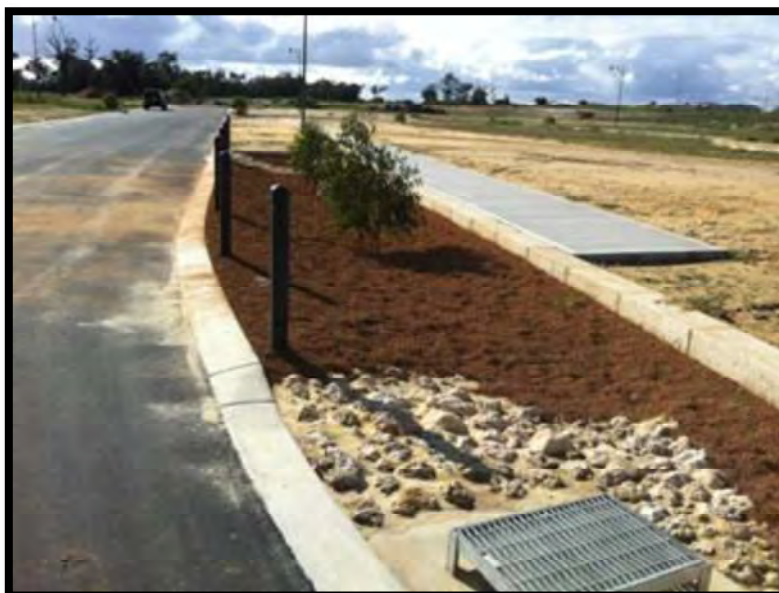
Figure 19
Indicative Verge Biofiltration Garden

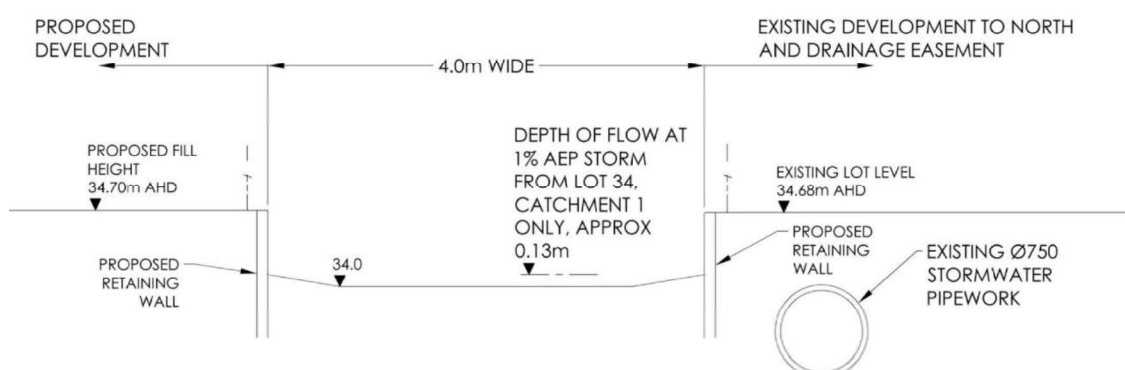
Given that the Lot 34 development proposes to drain the majority of its stormwater northwards into the POS/Drainage basin and the existing development to the north drains its catchment southwards into its POS/Drainage basin, then the POS/drainage basins are trapped with only a piped outlet. Piped outlets for 1.0% AEP storm events are generally unacceptable due to the variable nature of storm events and potential for blockage. Therefore, it is proposed to provide a surface stormwater relief path from the proposed POS through the indicated drainage reserve, beneath the existing Shire drainage easement within adjoining Lot 315 and discharging into the Government Rd North drain within Lot 33 (to the north west of the Lot 34 development). The culvert is shown on the above Figure 23 and the indicative cross section for the drainage reserve is included below as Figure 24.

Figure 24
Drainage Reserve – Indicative Cross Section

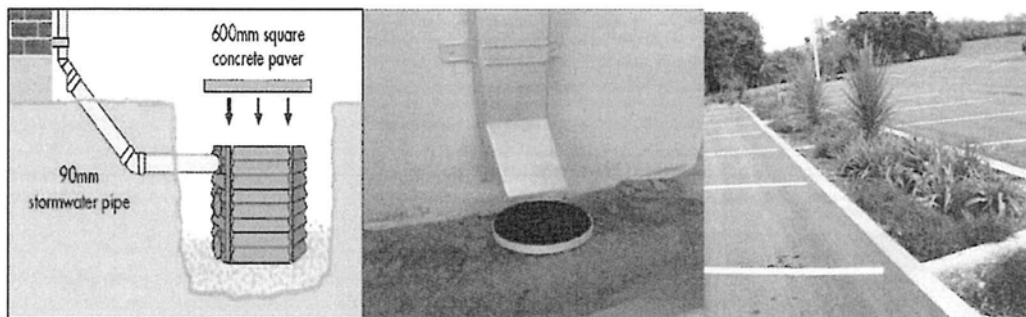
Typical Soakwell

The Shire also recommends that your gutter and downpipes have an overflow relief in the event of a blockage in the stormwater system. This can be achieved by not having the downpipe directly connected to the below ground stormwater pipes. (Refer picture)
