# LOCAL STRUCTURE PLAN

**PROJECT TITLE: Treendale Structure Plan Policy Area 3B (amended)**

DATE: 22<sup>nd</sup> DECEMBER 2020

TREENDALE POLICY AREA 3B  
AMENDED LOCAL  
STRUCTURE PLAN

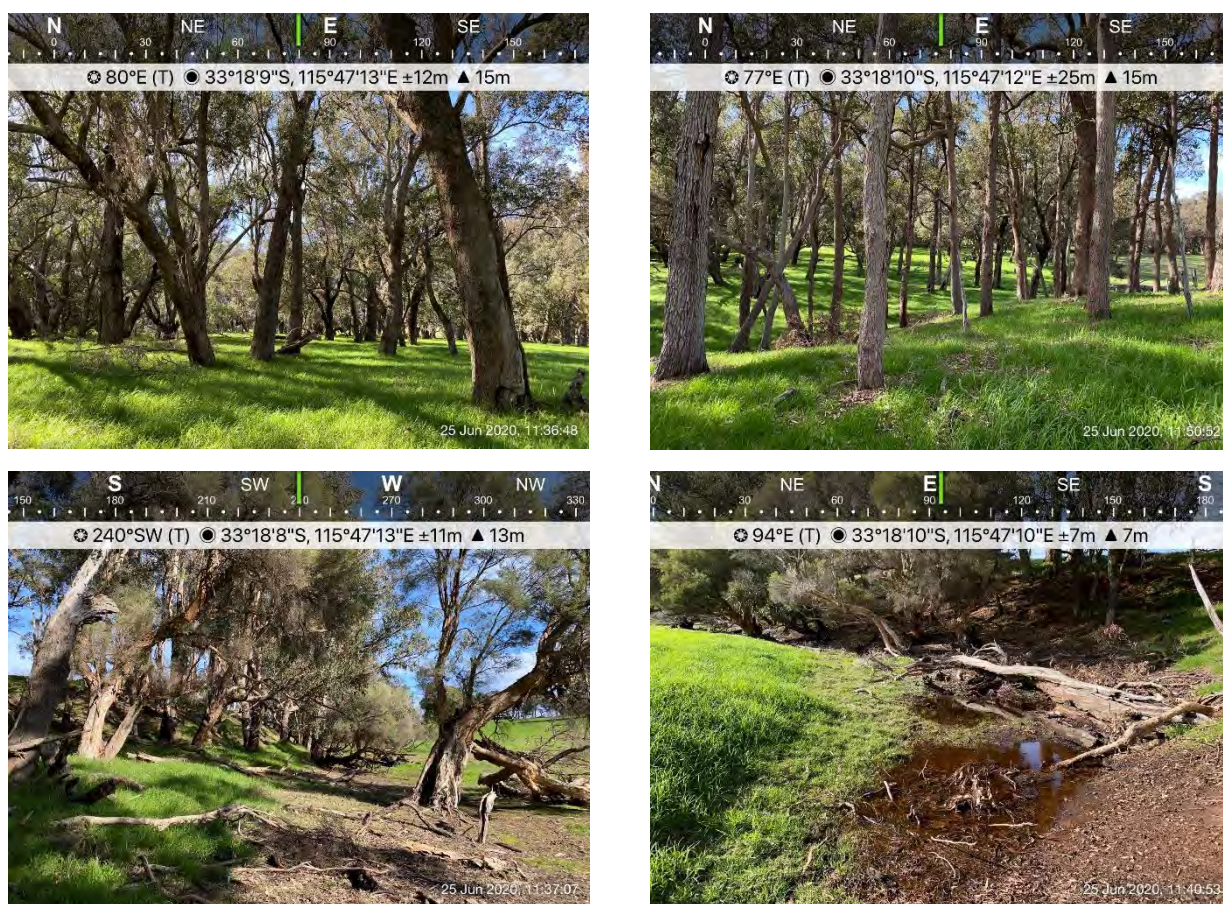
Figure 2: Photographs of the *Corymbia calophylla* woodland vegetation type, including the *Melaleuca raphiophylla* lined creek-line.

This vegetation type is approximately 0.84ha in size and is located along the eastern boundary of the Survey Area within the Collie River Floodplain (UFI 1736). It is described as *Corymbia calophylla* woodland over *\*Cenchrus clandestinus*, *\*Lolium perenne*, *\*Bromus diandrus*, *\*Briza maxima* and *\*B. minor* grassland. There are *Melaleuca raphiophylla* trees that line the small seasonal creek line area. The vegetation lacks any native mid or understorey species. This area of vegetation is surrounded by grazed pasture vegetation / paddocks and connects into adjacent wetland / floodplain vegetation. There are several well-worn cattle tracks through the area. Refer to Figure 2 below for photographs of the *Corymbia calophylla* woodland vegetation type.

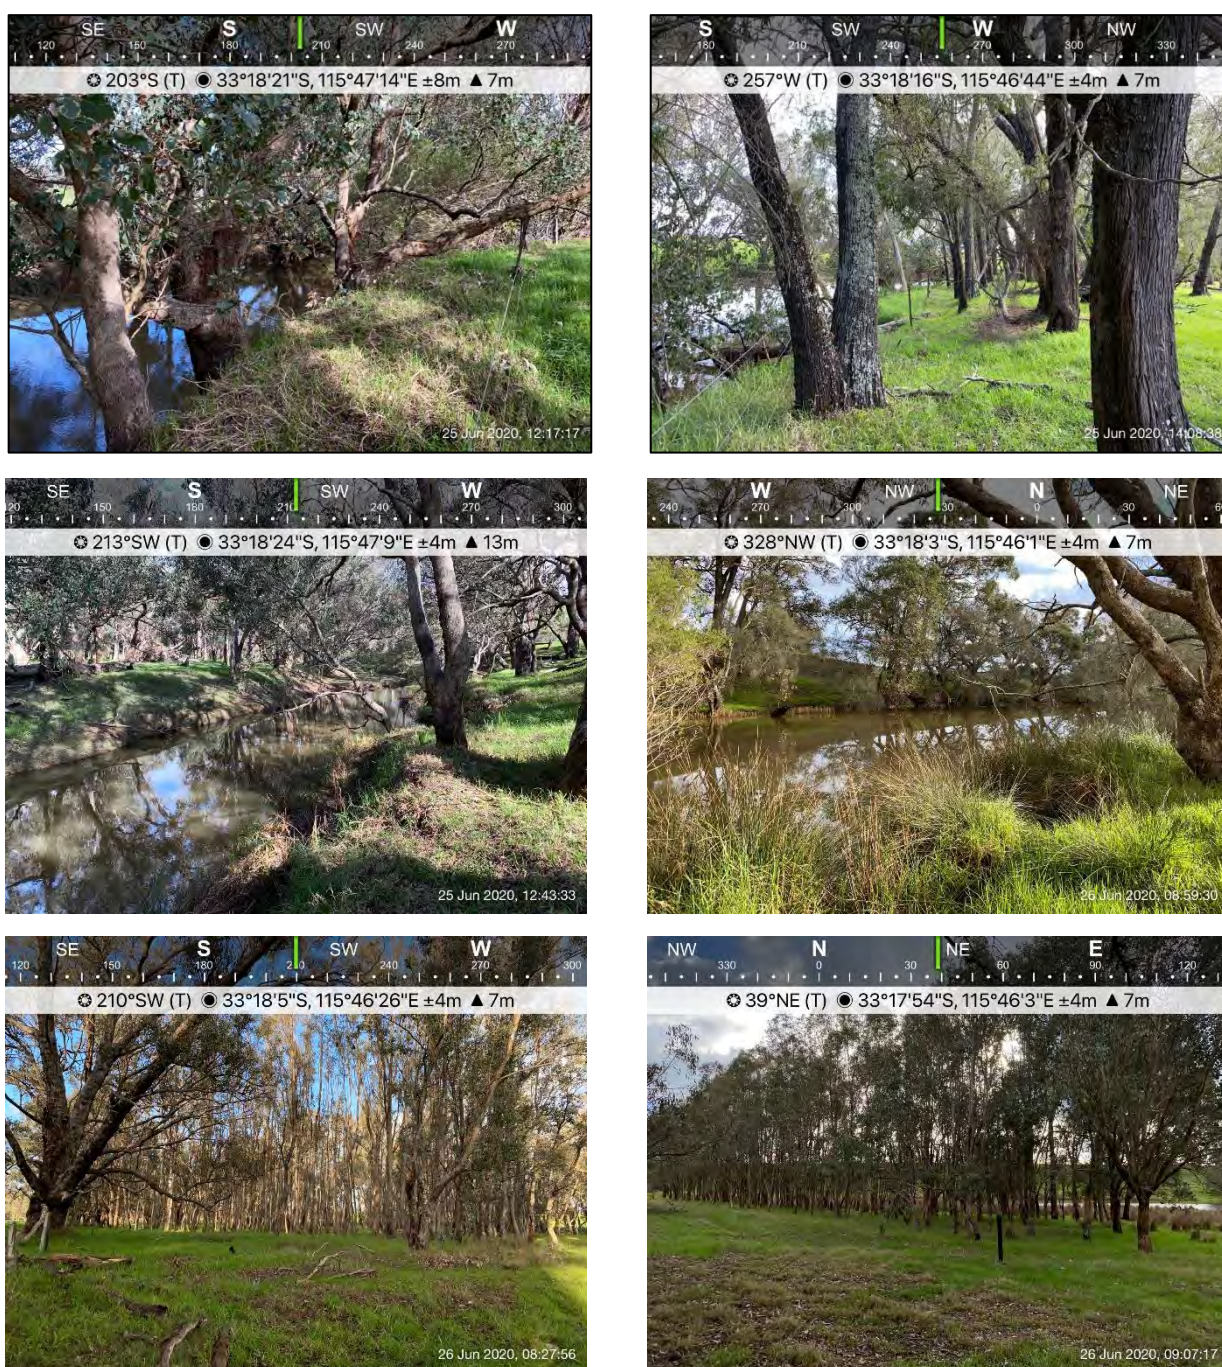
Figure 3: Photographs of the Eucalyptus rudis & Corymbia calophylla woodland vegetation type.

This vegetation type is described as Eucalyptus rudis and Corymbia calophylla woodland, over mixed introduced grass and herb grassland. The overstorey consists of mixed Eucalypts with sections where Agonis flexuosa and Melaleuca raphiophylla are present (and occasionally more dominant). This vegetation type also contains the stands of mixed Eucalyptus rudis and occasional Eucalyptus gomphocephala that are located to the west of both UFI 1870 and UFI 1719 (refer to Figure 3 below). The vegetation is generally devoid of native mid and understorey species, with the understorey consisting of introduced herbs and grasses. Commonly identified introduced species recorded in this vegetation type are \*Oxalis pes-caprae, \*Phytolacca octandra, \*Briza maxima, \*Briza minor, \*Bromus diandrus, \*Cenchrus clandestinus, \*Cynodon dactylon, \*Holcus lanatus, \*Lolium perenne and \*Rumex pulcher.

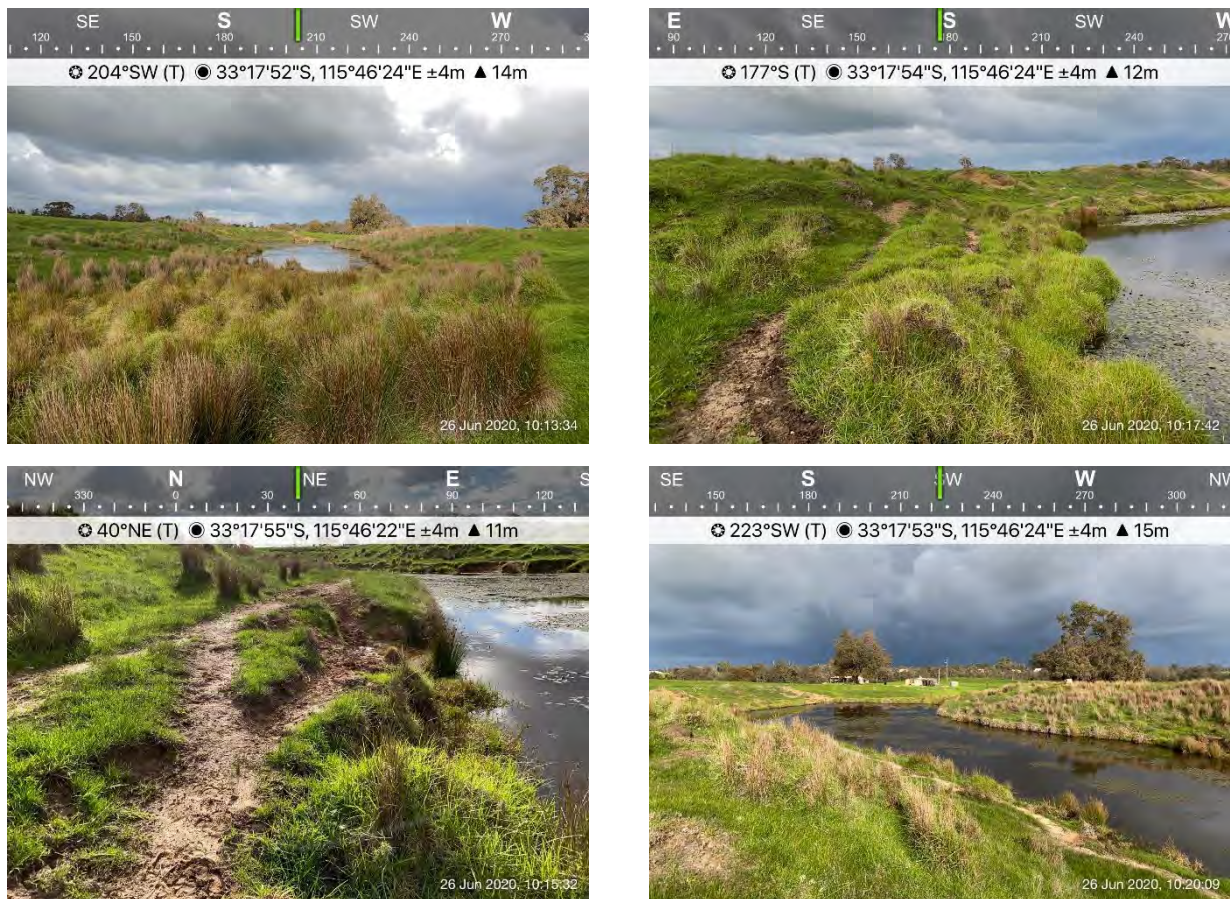
Figure 6: Photographs of the *Juncus subsecundus*, *Juncus* sp. and *Cenchrus clandestinus* grassland vegetation type.

This vegetation type is associated with UFI 15223 and is located to the east of UFI 1719. This vegetation consists solely of *Juncus* and *Cenchrus clandestinus* and is approximately 0.49ha in size. There is also an aquatic weed species that was present in the standing water and unable to be identified. The presence of this aquatic species indicates this area is permanently inundated. It is clear that the cattle utilise this as a source of drinking water due to the degraded banks. Refer to Figure 6 over the page for photographs of this vegetation type.

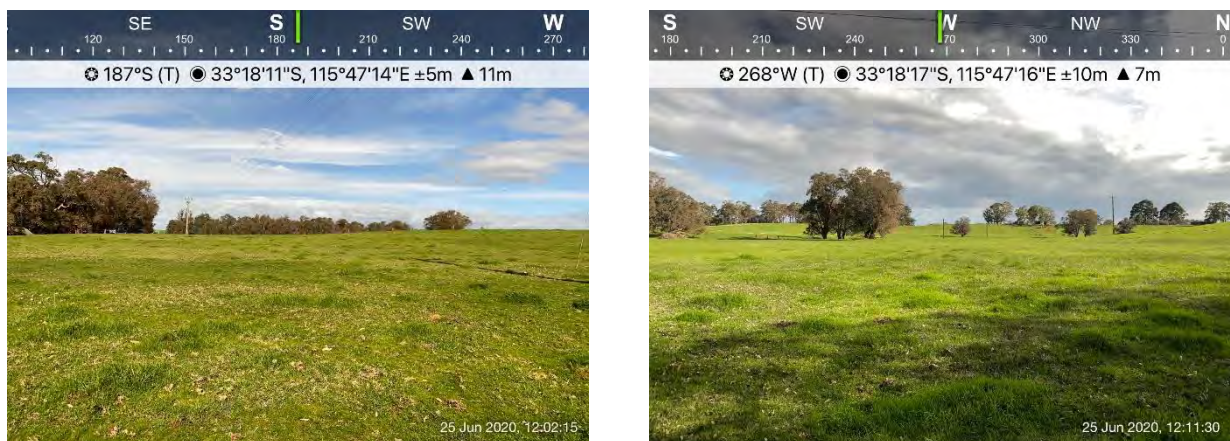
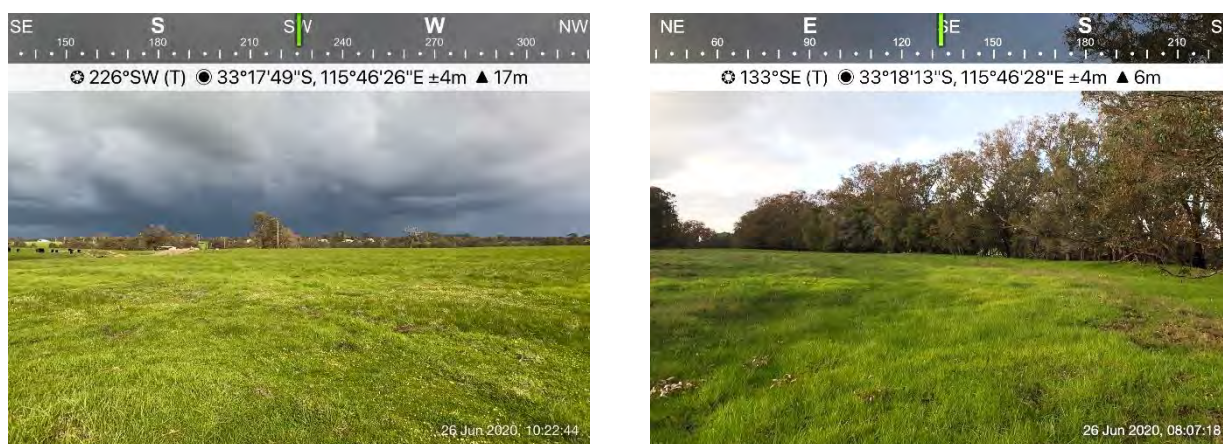
Figure 7: Photographs of the bare and cleared areas throughout the Survey Area and Subject Site.

The remainder of the Survey Area and the majority of the Subject Site consists of bare cleared areas utilised for cattle grazing. This vegetation type is associated with the multiple use UFI 15223, and within UFI 1736. This vegetation type is dominated by introduced pasture and weed species as well as scattered paddock trees. Given this area is predominantly outside of the Survey Area it was not intensely surveyed. Refer to Figure 7 below for photographs of the vegetation type.

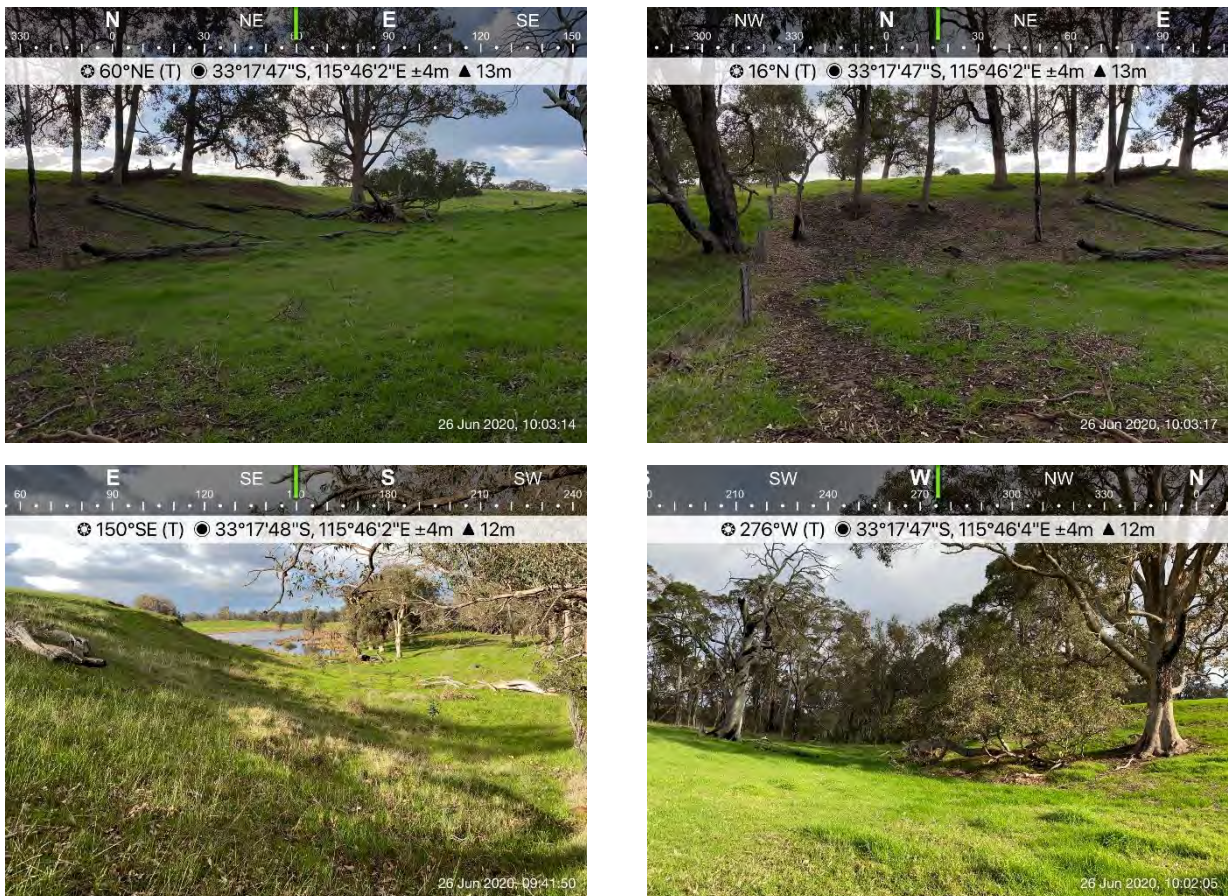
Figure 9: Photographs of vegetation within potential mapped TEC area.

No Priority or Threatened Ecological Communities were observed within the Survey Area. The Banksia Dominated Woodlands of the Swan Coastal Plain IBRA Region (P3 / EN) community that was mapped as being potentially present within the north west of the Survey Area was not deemed to be present. This area of vegetation has been previously cleared, with only paddock trees remaining. Please refer to Figure 9 below.

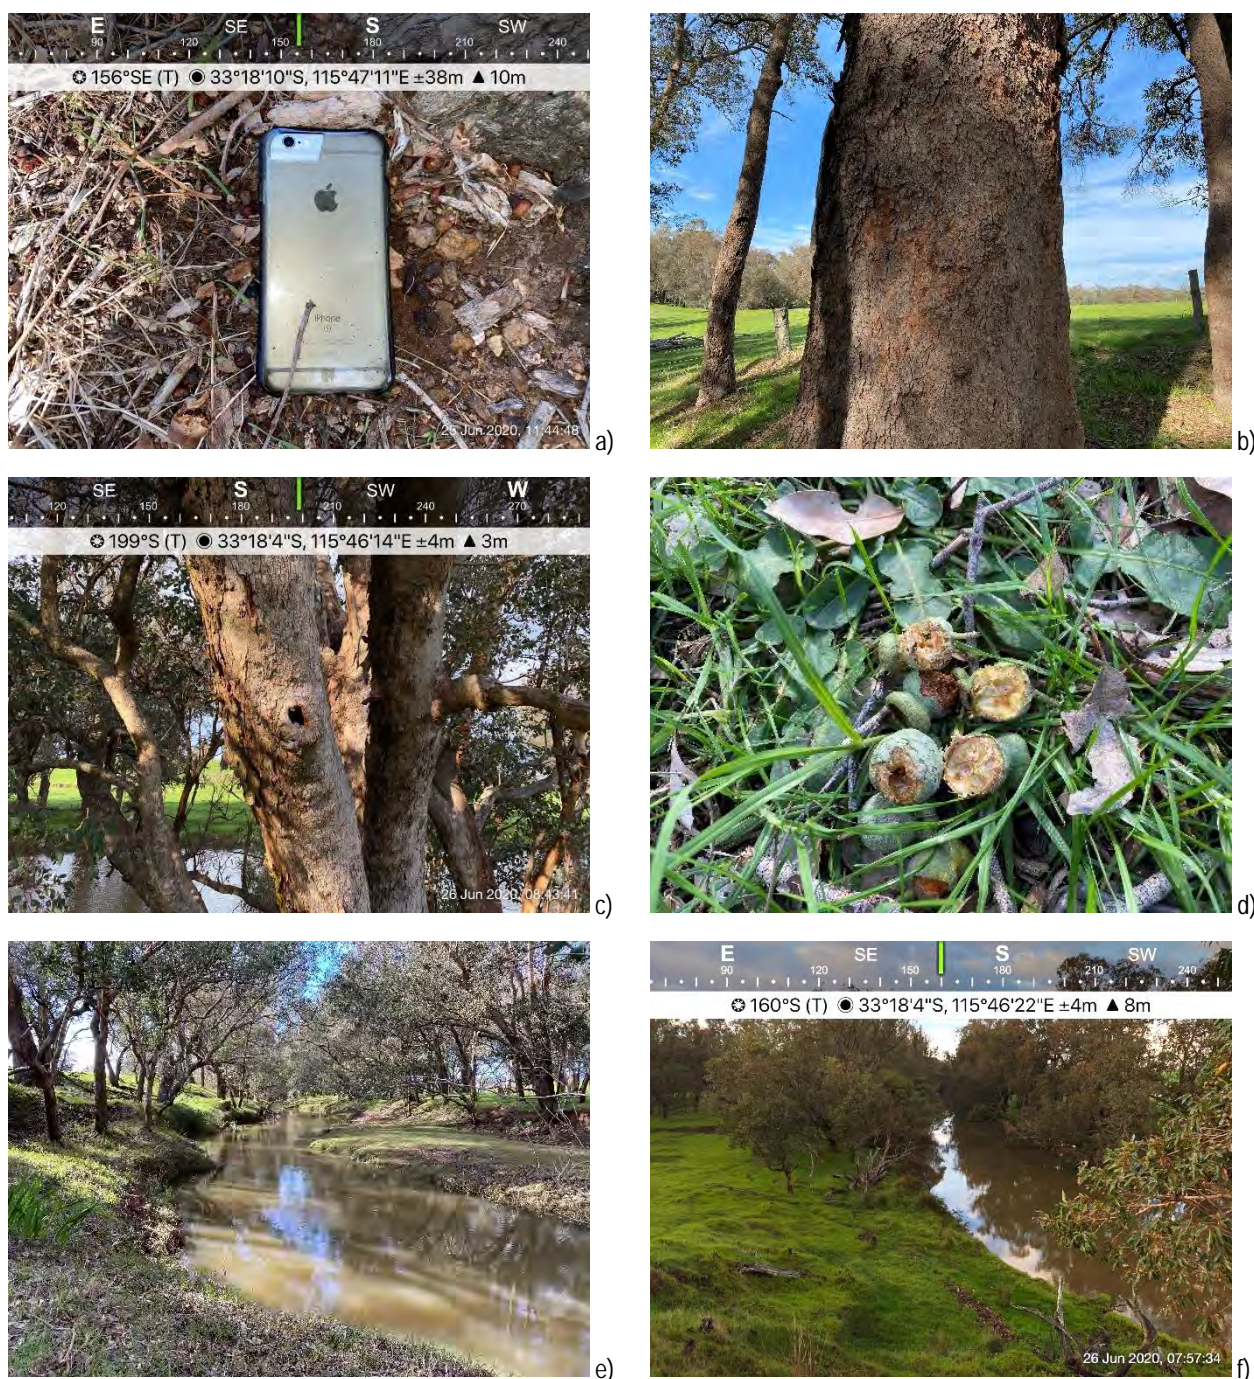
Figure 10: Photographs of faunal indicators and potential habitat.

Photographs a) & b): brushtail possum scat and tree scratchings; c) small hollow located in vegetation along the Collie River; d) chewed marri nuts; e) & f) photographs of the adjacent Collie River that may provide habitat for water birds and the water rat.

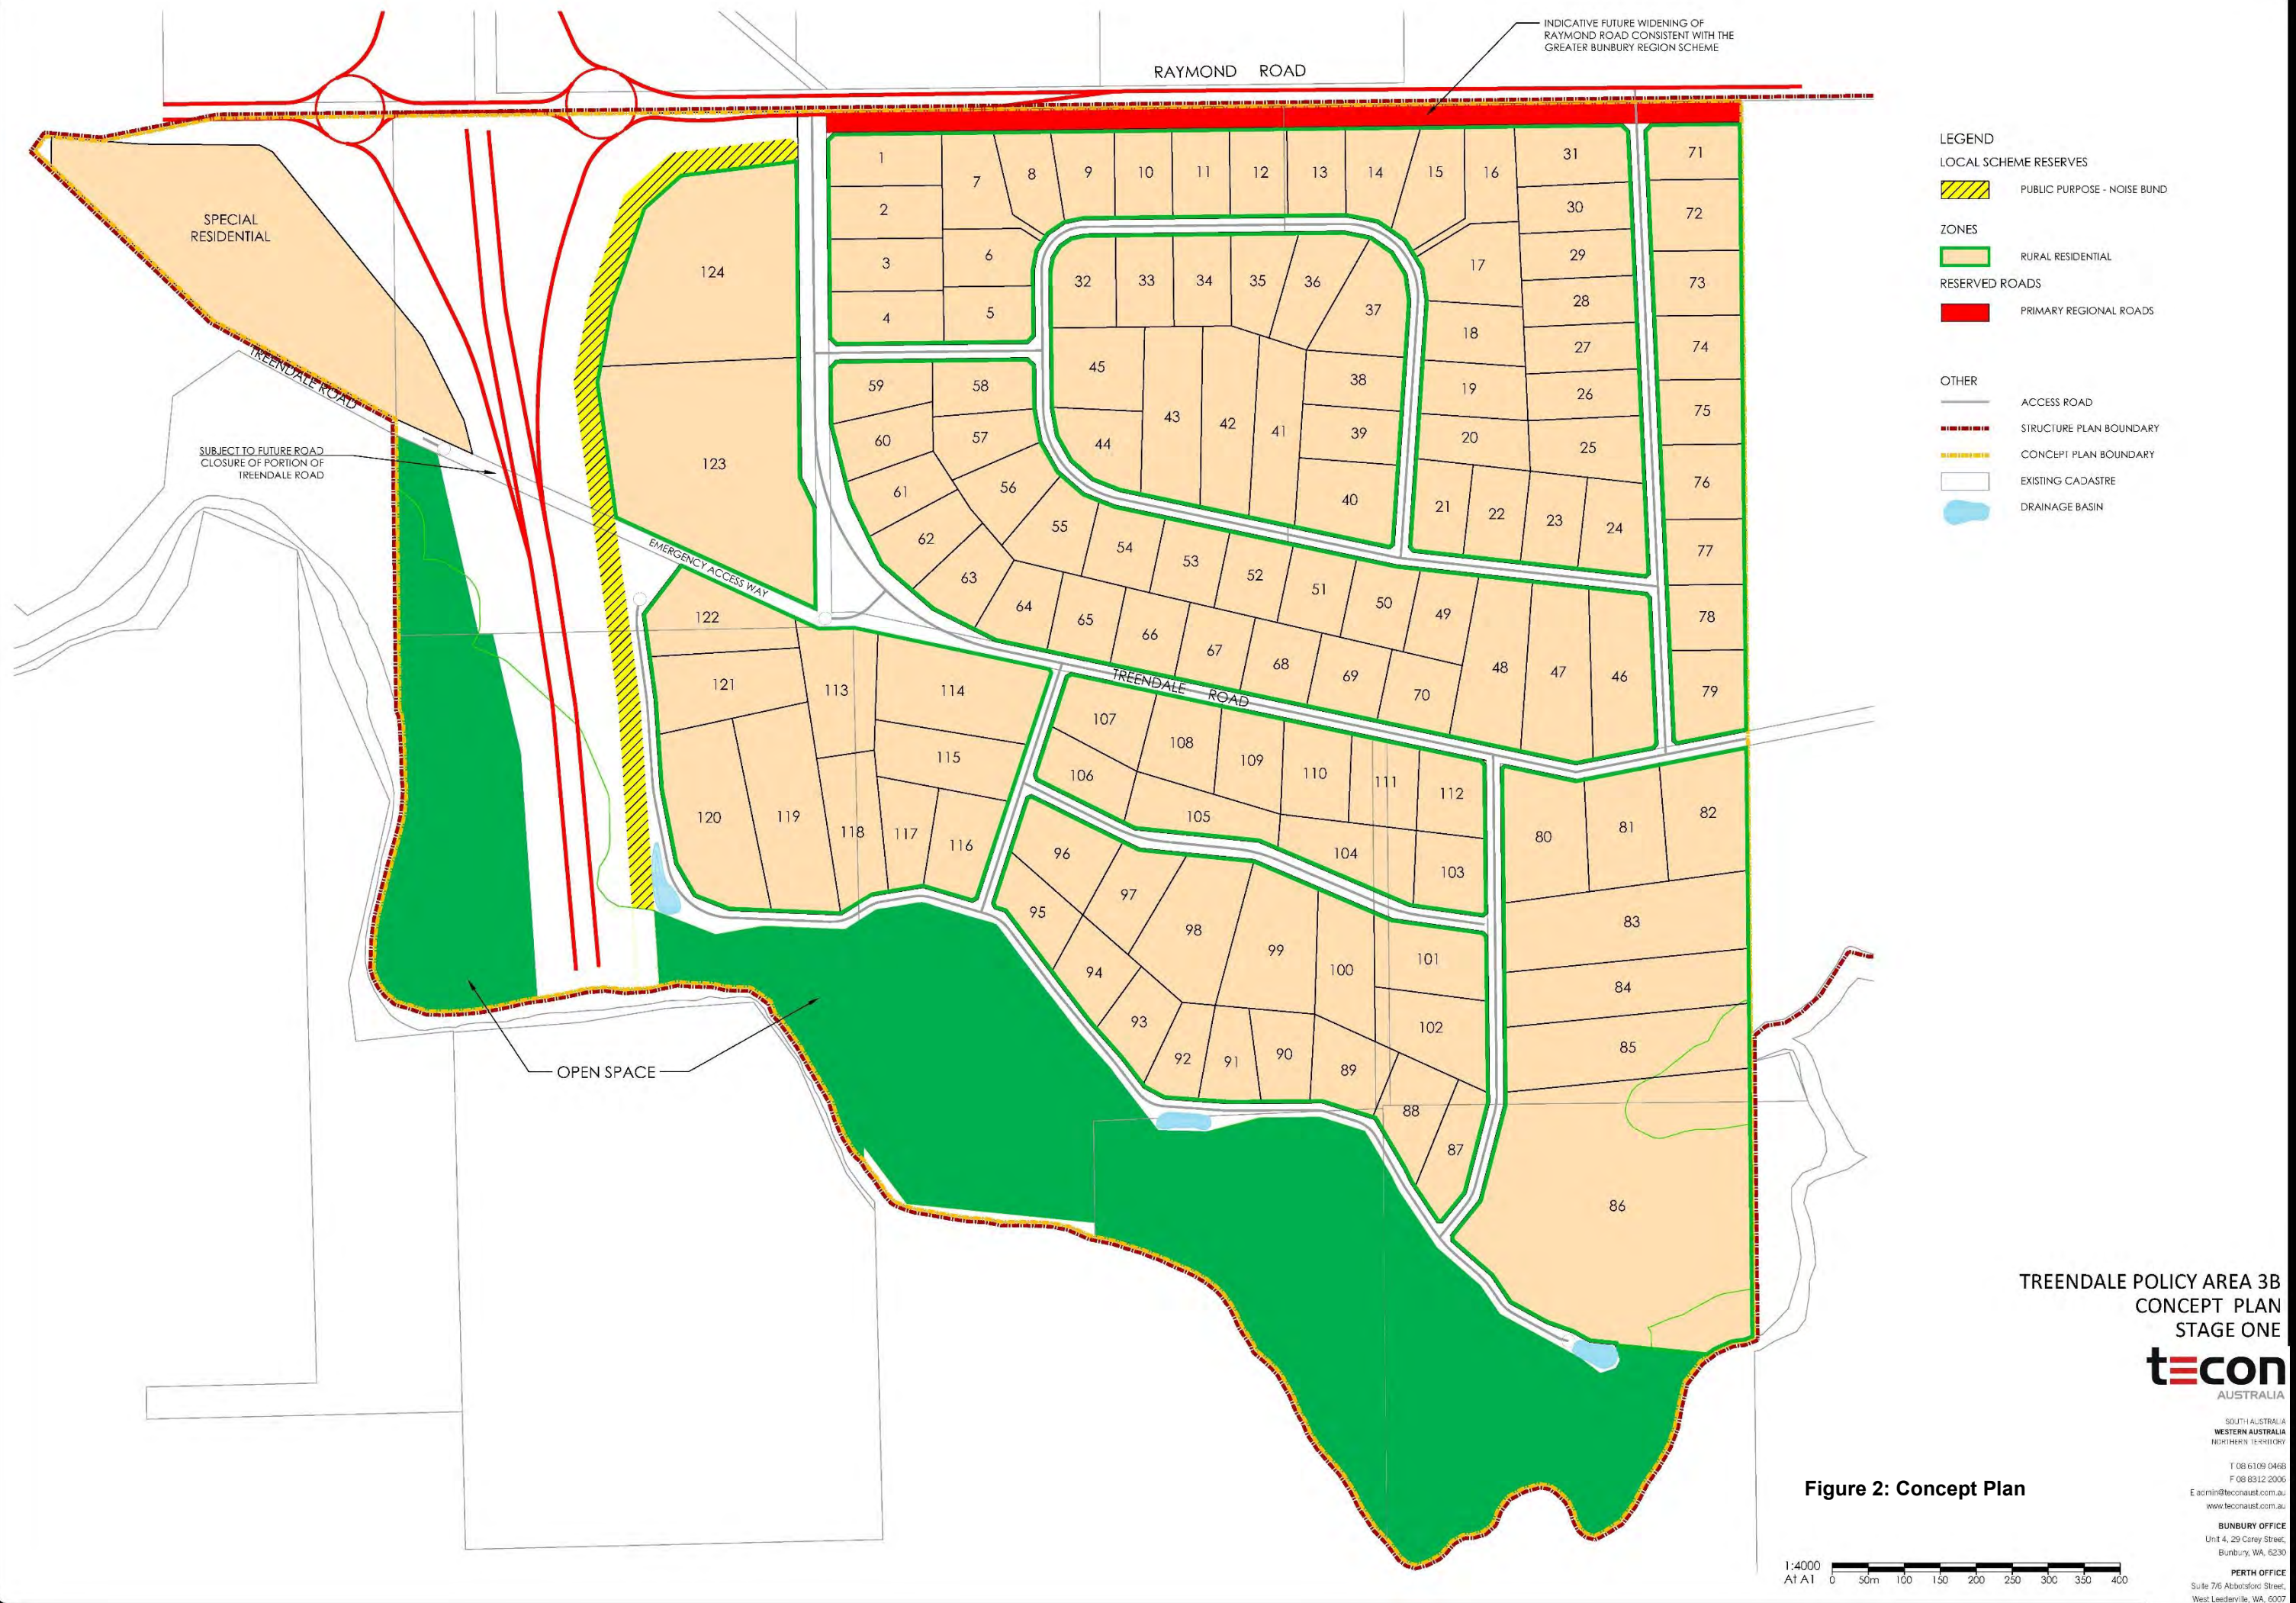
Figure 2: Concept Plan

The Amended Structure Plan will provide the framework for the coordinated provision and arrangement of the land uses, subdivision and development. It will also inform the provision of a transport network, public open space, public utilities, development standards, community infrastructure and urban water management.

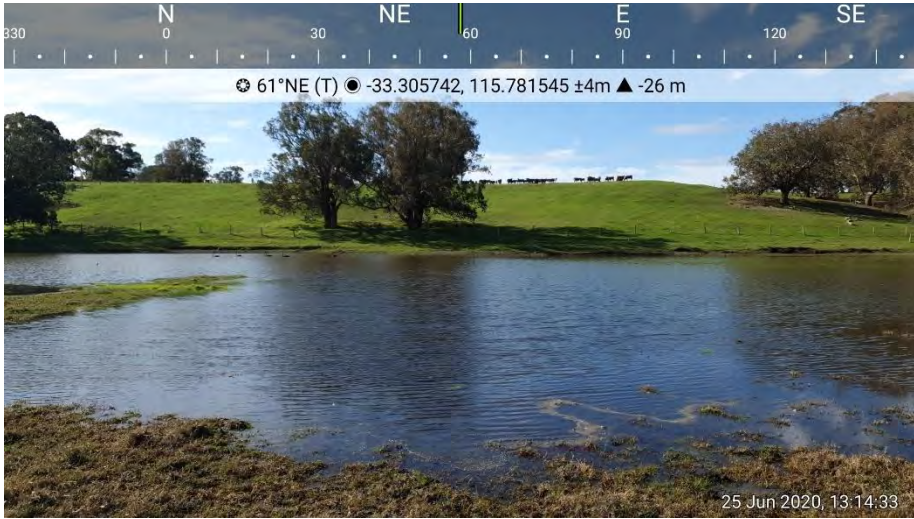
Plot	1	Classification or Exclusion Clause	Low fuel or non-vegetated areas exclusion 2.2.3.2 (e)

<p><b>Location:</b> External to the site to the north. Internal to the site through the middle running east-west as well as south and south-west of the subject site.</p> <p><b>Description:</b> Roads, driveways, buildings, seasonally inundated areas and other non-vegetated areas.</p> <p>As per exclusion clause 2.2.3.2 (e) of AS3959-2018.</p>
Photo Id 1: View facing north-east towards seasonally inundated area located central south to the subject site.			
Plot	1 cont.	Classification or Exclusion Clause	Low fuel or non-vegetated areas exclusion 2.2.3.2 (e)

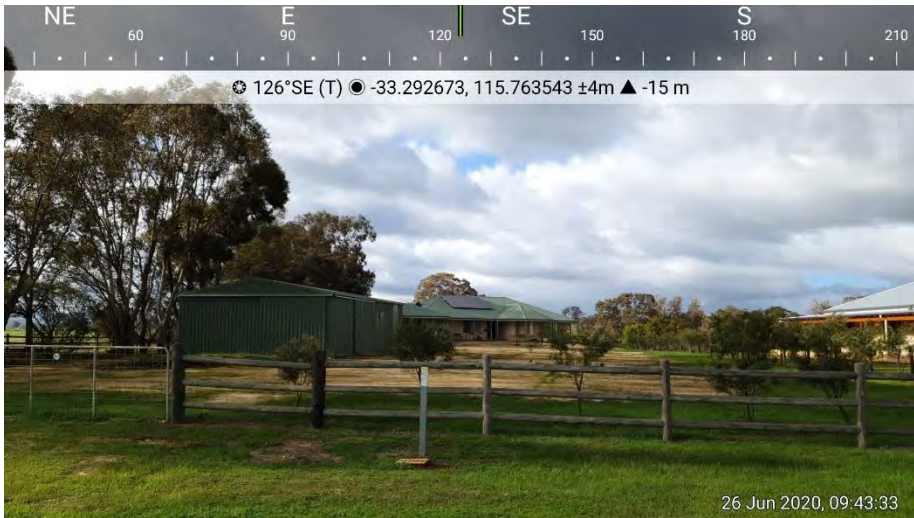
Plot	2	Classification or Exclusion Clause	Low fuel or non-vegetated areas exclusion 2.2.3.2 (f)

<p><b>Location:</b> North-west of the subject site.</p> <p><b>Description:</b> Managed Asset Protection Zones (APZ) in existing residential area including managed lawns and gardens.</p> <p><b>Available fuel loading:</b> &lt;2 t/ha.</p> <p>As per exclusion clause 2.2.3.2 (f) of AS3959-2018.</p>

*Photo 1d 3: View to the south-east towards managed APZ area located to the north-west of the subject site.*

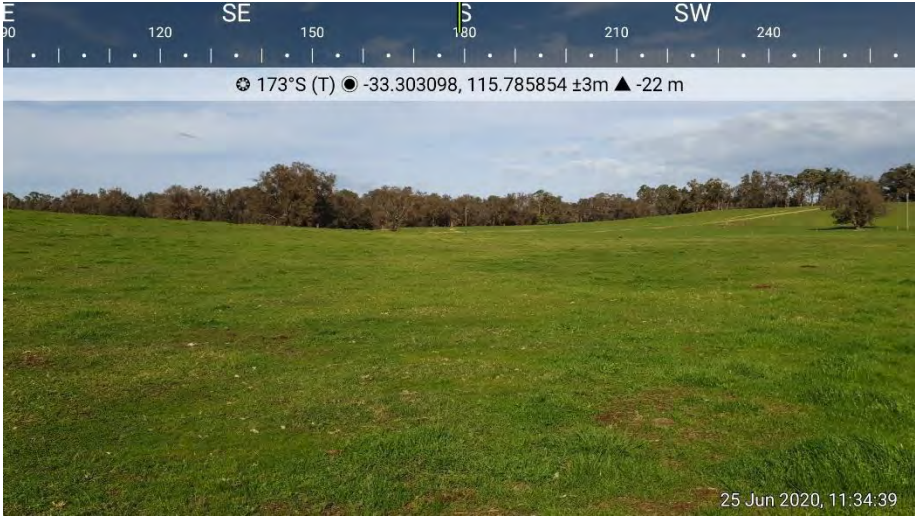
<p><b>Location:</b> Internal to the subject site and external to the north and east.</p> <p><b>Separation Distance:</b> 0m to the internal and external vegetation.</p> <p><b>Description</b> Partially grazed mixed grasses and weeds.</p> <p><b>Average vegetation height:</b> 100-300mm.</p> <p><b>Vegetation Coverage:</b> &lt;10% trees.</p> <p><b>Available fuel loading:</b> 4.5t/ha.</p> <p><b>Effective slope:</b> Downslope &gt;0-5 Degrees.</p>
<p><i>Photo Id 6: View facing south towards grassland vegetation located central east of the subject site.</i></p>

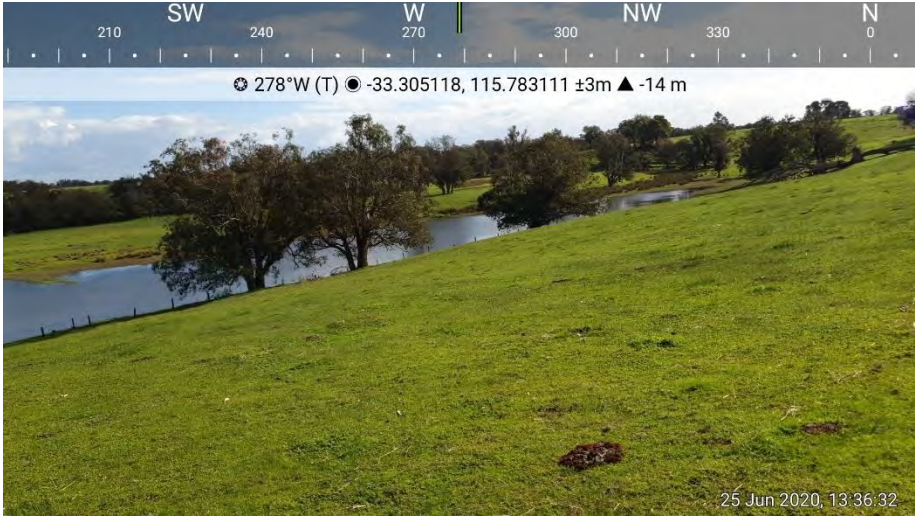
<p><b>Location:</b> Ridge line area internal to the subject site to the north of the wetland/floodplain areas. Extends outside the subject site along the western and eastern boundaries.</p> <p><b>Separation Distance:</b> 0m.</p> <p><b>Description</b> Partially grazed mixed grasses and weeds.</p> <p><b>Average vegetation height:</b> 100-300mm.</p> <p><b>Vegetation Coverage:</b> &lt;10% trees.</p> <p><b>Available fuel loading:</b> 4.5t/ha.</p> <p><b>Effective slope:</b> Downslope &gt;5-10 Degrees.</p>
Photo Id 8: View facing west towards grassland vegetation located central south to the subject site.

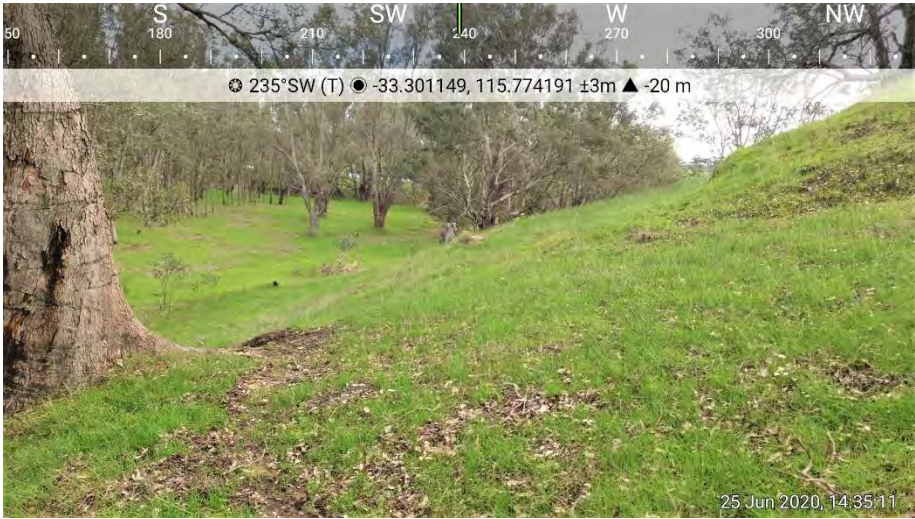
Plot	7	Classification or Exclusion Clause	Grassland Type G

<p><b>Location:</b> Ridge line internal to the subject site to the south</p> <p><b>Separation Distance:</b> 0m.</p> <p><b>Description</b> Partially grazed mixed grasses and weeds.</p> <p><b>Average vegetation height:</b> 100-300mm.</p> <p><b>Vegetation Coverage:</b> &lt;10% trees.</p> <p><b>Available fuel loading:</b> 4.5t/ha.</p> <p><b>Effective slope:</b> Downslope &gt;15-20 Degrees.</p>
Photo Id 11: View facing south-west towards grassland vegetation located central south of the subject site.			
Plot	8	Classification or Exclusion Clause	Forest Type A

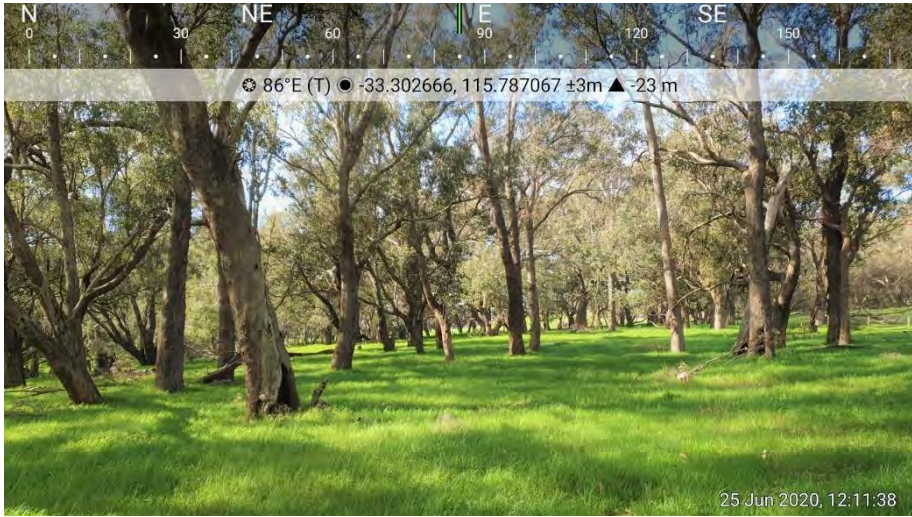
Plot	9	Classification or Exclusion Clause	Forest Type A

<p><b>Location:</b> Internal and external to the subject site to the east and north-west.</p> <p><b>Separation Distance:</b> 0m to the boundary of the subject site in the north-east, south-east, south and south-west.</p> <p><b>Description:</b> Mixed Eucalyptus and Melaleuca trees with grass understorey. No multilayering</p> <p><b>Average vegetation height:</b> 10-20m.</p> <p><b>Vegetation Coverage:</b> 30-70% foliage cover.</p> <p><b>Available fuel loading:</b> 25-35t/ha.</p> <p><b>Effective slope:</b> Downslope &gt;0-5 Degrees.</p>

*Photo Id 14: View facing east towards forest vegetation located central east of the subject site.*

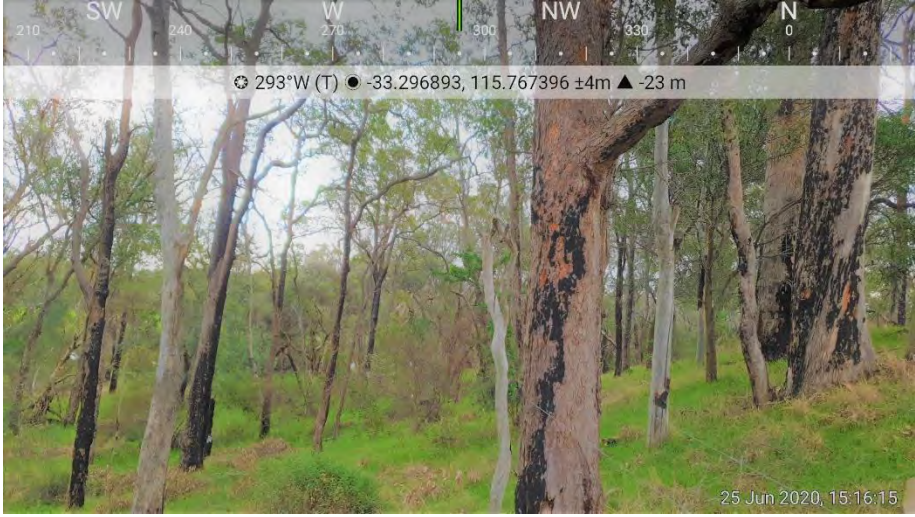
Plot	10	Classification or Exclusion Clause	Forest Type A

<p><b>Location:</b> Internal and external on the western boundary of the subject site.</p> <p><b>Separation Distance:</b> 0m.</p> <p><b>Description:</b> Mixed Eucalyptus and Melaleuca trees with grass understorey. No multilayering</p> <p><b>Average vegetation height:</b> 10-20m.</p> <p><b>Vegetation Coverage:</b> 30-70% foliage cover.</p> <p><b>Available fuel loading:</b> 25-35t/ha.</p> <p><b>Effective slope:</b> Downslope &gt;10-15 Degrees.</p>

*Photo Id 16: View facing west north-west towards forest vegetation located central west of the subject site.*

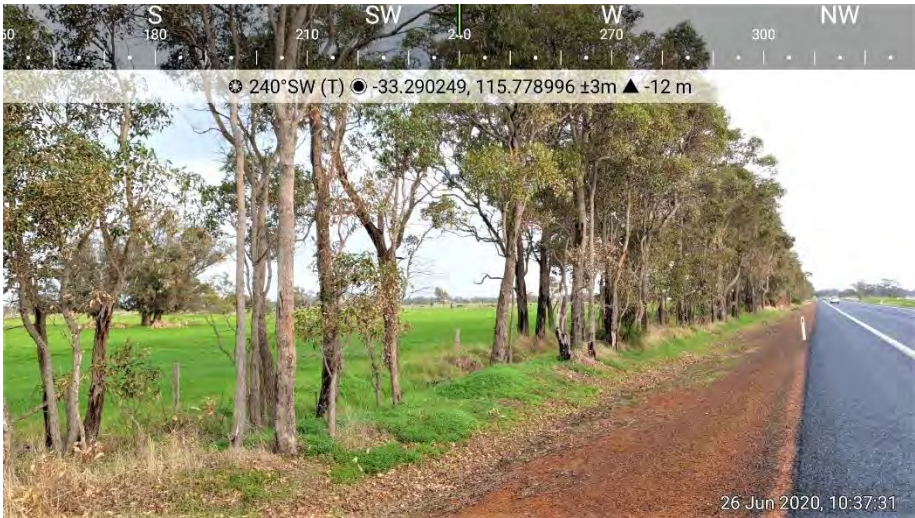
Plot	12	Classification or Exclusion Clause	Forest Type A

<p><b>Location:</b> Thin strips of vegetation along Raymond Road to the north of the subject site.</p> <p><b>Separation Distance:</b> 0m to the boundary of the subject site in the north.</p> <p><b>Description:</b> Roadside vegetation and strips of plantation trees consisting of mixed Eucalyptus species. Dense canopy cover with a multilayered scrub understorey.</p> <p><b>Average vegetation height:</b> 10-20m.</p> <p><b>Vegetation Coverage:</b> 30-70% foliage cover.</p> <p><b>Available fuel loading:</b> 25-35t/ha.</p> <p><b>Effective slope:</b> Upslope/flat.</p>

Photo Id 19: View facing south-west towards roadside vegetation on the south side of Raymond Road.

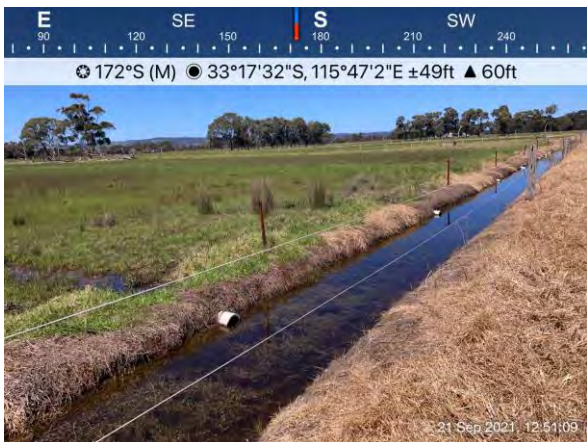
**Photo 3: View to the south of open channel distribution network located in the north. The drains were historically used for irrigation via flood irrigation techniques. The drains at the time of the site investigation were filled with groundwater.**

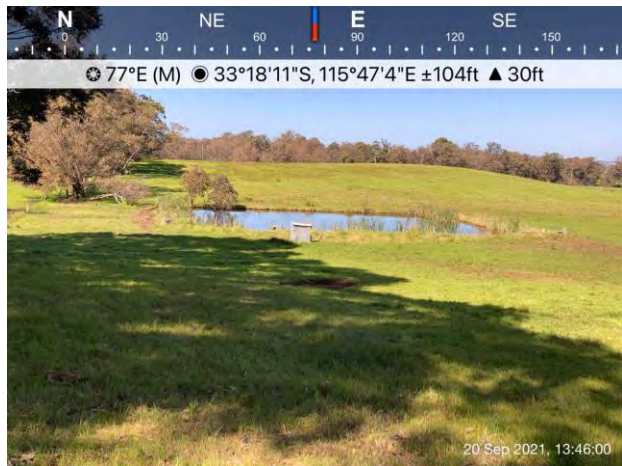
**Photo 2: View to the east of one of several farm dams on the property. Most farm dams will be commissioned as part of development works.**

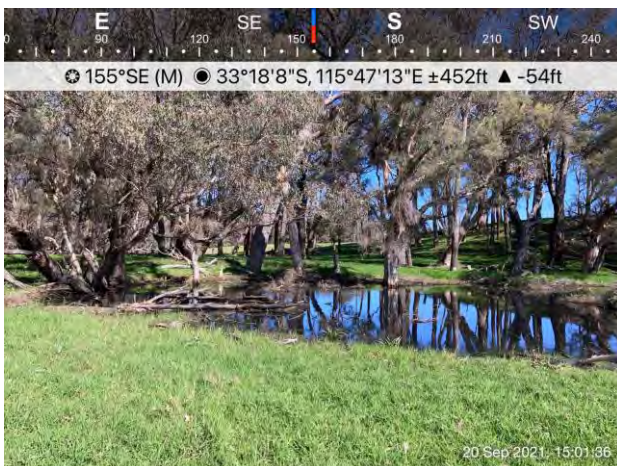
**Photo 3: View to the southeast of wetland within the southeast of the Subject Site. This wetland will have a development setback buffer of 100m.**

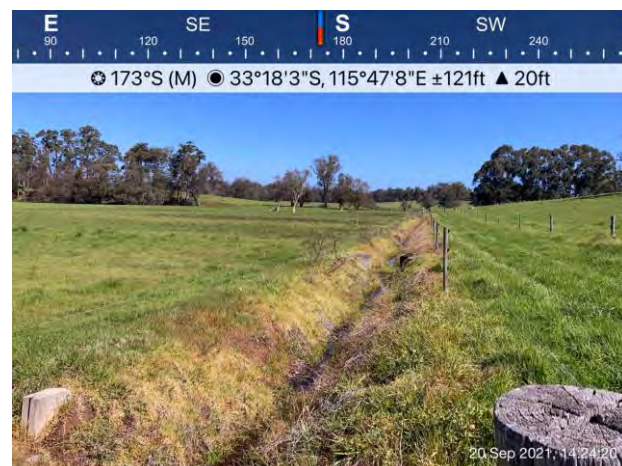
**Photo 4: View to the south of cut drain in the southeast of the site. Cut drains in the Subject Site south of Treendale Road appear to be constructed for drainage of the site where as the drains in the north were constructed for historical flood irrigation use.**

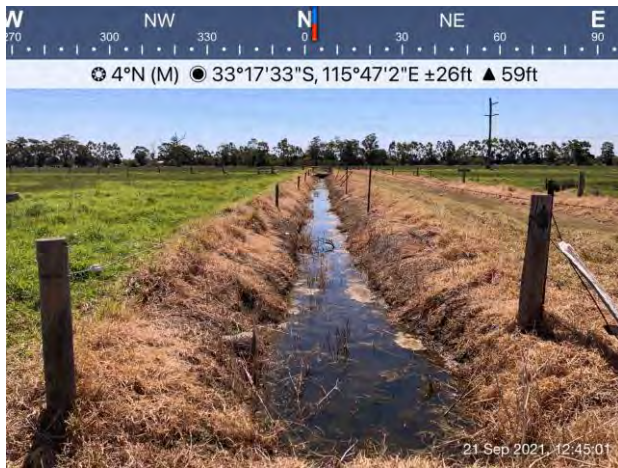
**Photo 5: View to the north of constructed drain within the northeast of the site.**

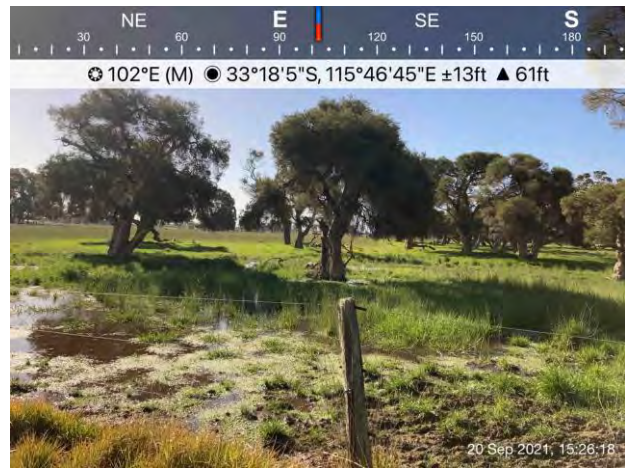
**Photo 6: View to the east of seasonally inundated area in the central south. This area is dominated by paperbark trees.**

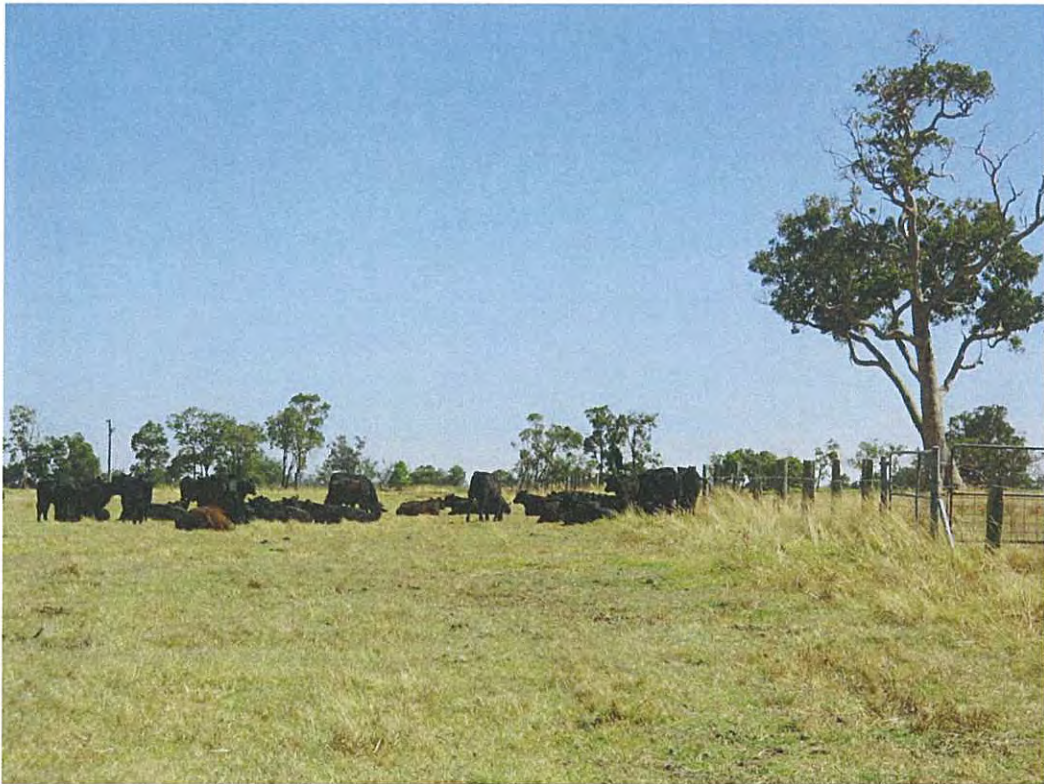
Plate 15      Condition of vegetation in northern portion of study area – eastern end

Furthermore, it does not retain any attributes of a wetland and does not support any wetland dependant vegetation. It is therefore considered that the classification of this area being a wetland is not consistent with the observed characteristics of this portion of the study area. The typical condition of the northern portion of the study area is shown in **Plates 15 and 16**.

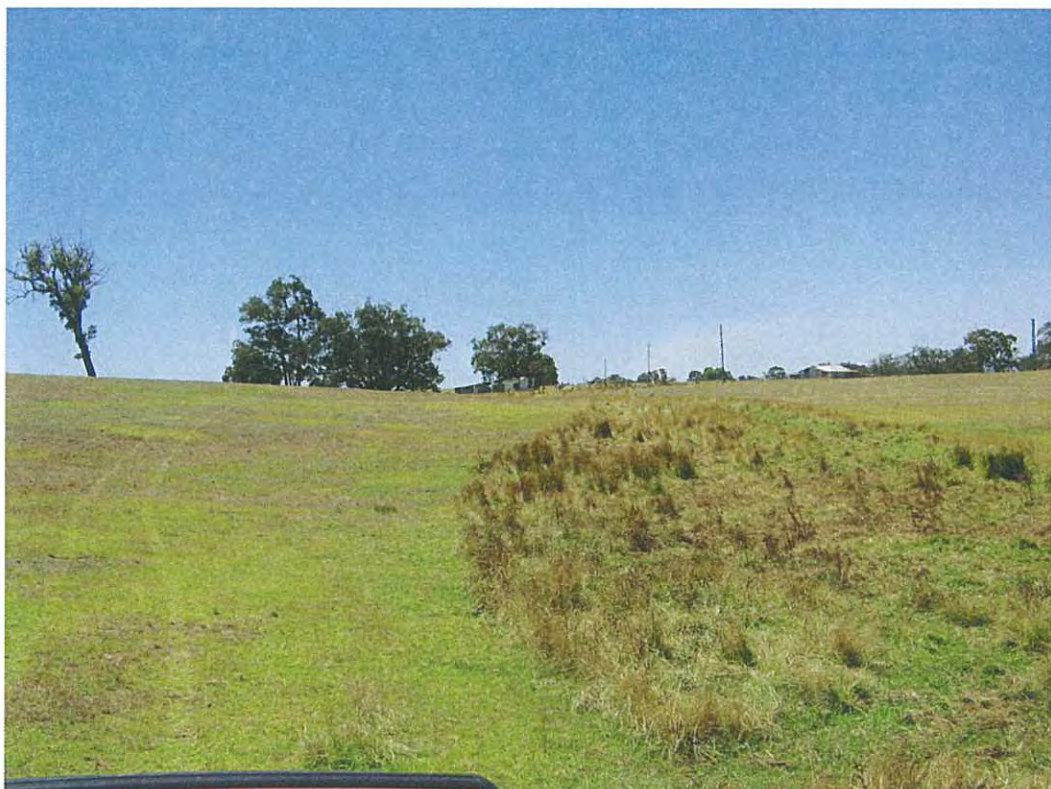
Plate 16      Condition of vegetation in north portion of study area – western end

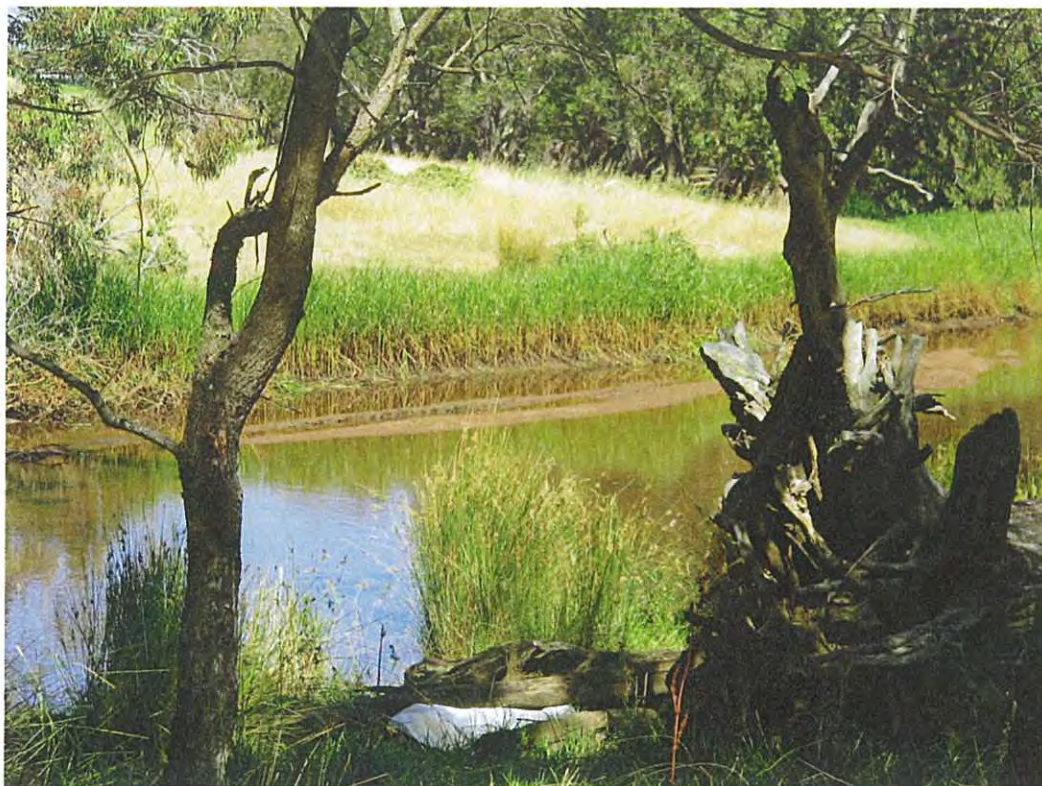
Plate 17      Condition of vegetation along Collie River (pt 1)

The floodplain of the Collie River within the study area is a part of a 347ha 'floodplain' that has been evaluated as MUW. This area has been mostly cleared for grazing, and remnant vegetation is limited to a thin strip of riparian vegetation along the Collie River. The typical condition of the 'floodplain' is shown in **Plates 17 and 18**. The entire floodplain area was observed to be currently utilised for grazing. Given the degraded condition of the floodplain area, it is considered that the MUW management category is appropriate. There is another approximately 3ha area located within the Collie River floodplain, that was not specifically identified within the Geomorphic Wetlands dataset, and this area appears to have characteristics consistent with a 'sumpland' wetland. This 'sumpland' wetland area is completely devoid of overstorey species, and has limited sedges and rushes that appear to have been impacted by stock grazing and trampling. The wetland does not retain any native vegetation buffer. The typical condition of the 'sumpland' is shown in **Plate 19**.
