# LOCAL STRUCTURE PLAN

**PROJECT TITLE: Treendale Structure Plan Policy Area 3B (amended)**

DATE: 22<sup>nd</sup> DECEMBER 2020

TREENDALE POLICY AREA 3B  
AMENDED LOCAL  
STRUCTURE PLAN

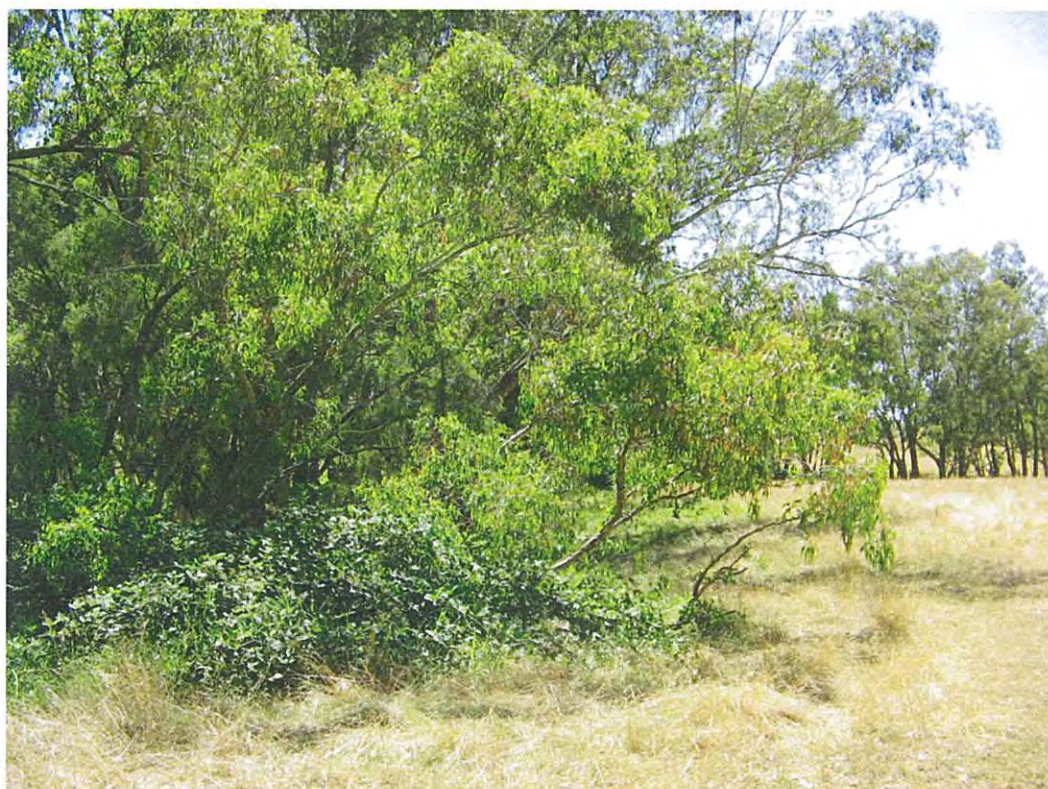
Plate 18      Condition of vegetation along Collie River (pt2)

The floodplain of the Collie River within the study area is a part of a 347ha 'floodplain' that has been evaluated as MUW. This area has been mostly cleared for grazing, and remnant vegetation is limited to a thin strip of riparian vegetation along the Collie River. The typical condition of the 'floodplain' is shown in **Plates 17 and 18**. The entire floodplain area was observed to be currently utilised for grazing. Given the degraded condition of the floodplain area, it is considered that the MUW management category is appropriate. There is another approximately 3ha area located within the Collie River floodplain, that was not specifically identified within the Geomorphic Wetlands dataset, and this area appears to have characteristics consistent with a 'sumpland' wetland. This 'sumpland' wetland area is completely devoid of overstorey species, and has limited sedges and rushes that appear to have been impacted by stock grazing and trampling. The wetland does not retain any native vegetation buffer. The typical condition of the 'sumpland' is shown in **Plate 19**.

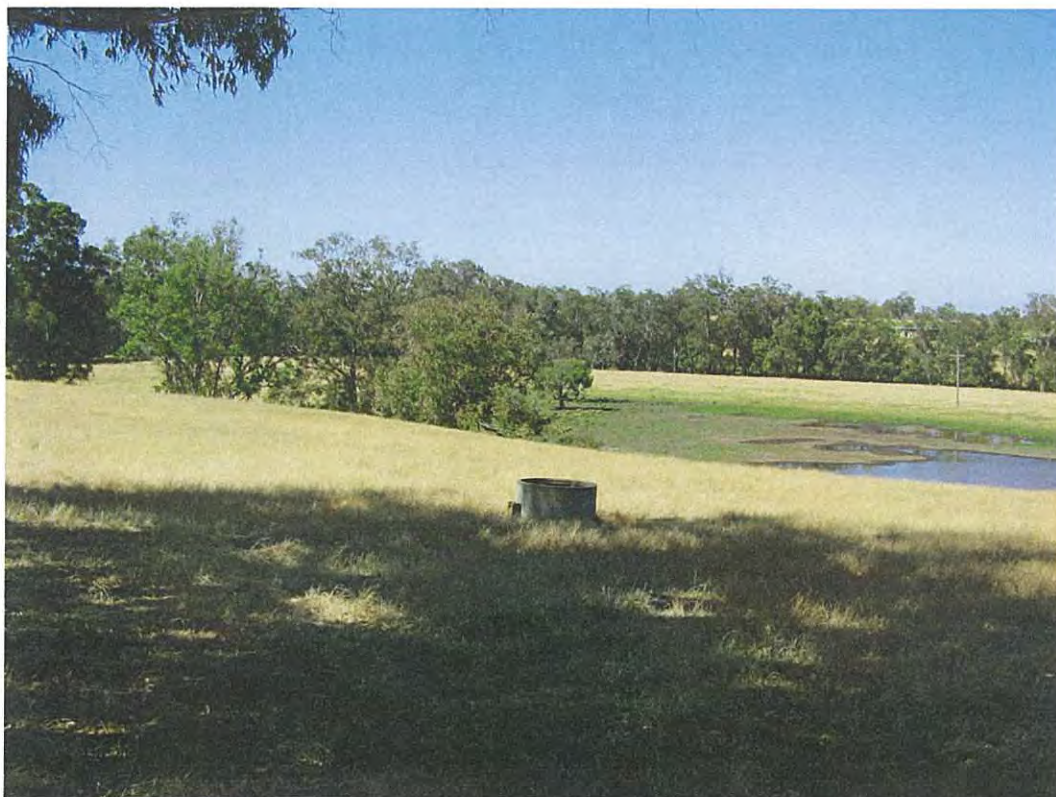
Plate 19 Condition of 'sumpland' area within wetland #1736

A further 'sumpland' is immediately adjacent to (though effectively encompassed by) the floodplain, being a 2.8ha MUW. This wetland is completely devoid of overstorey species, and vegetation is limited to degraded sedges and rushes. The sedges and rushes appear to have been degraded due to the influence of stock grazing and trampling. The wetland does not retain any surrounding vegetative buffer. The condition of this wetland is shown in **Plate 21**. Given the degraded condition of the floodplain area, it is considered that the MUW management category is appropriate.

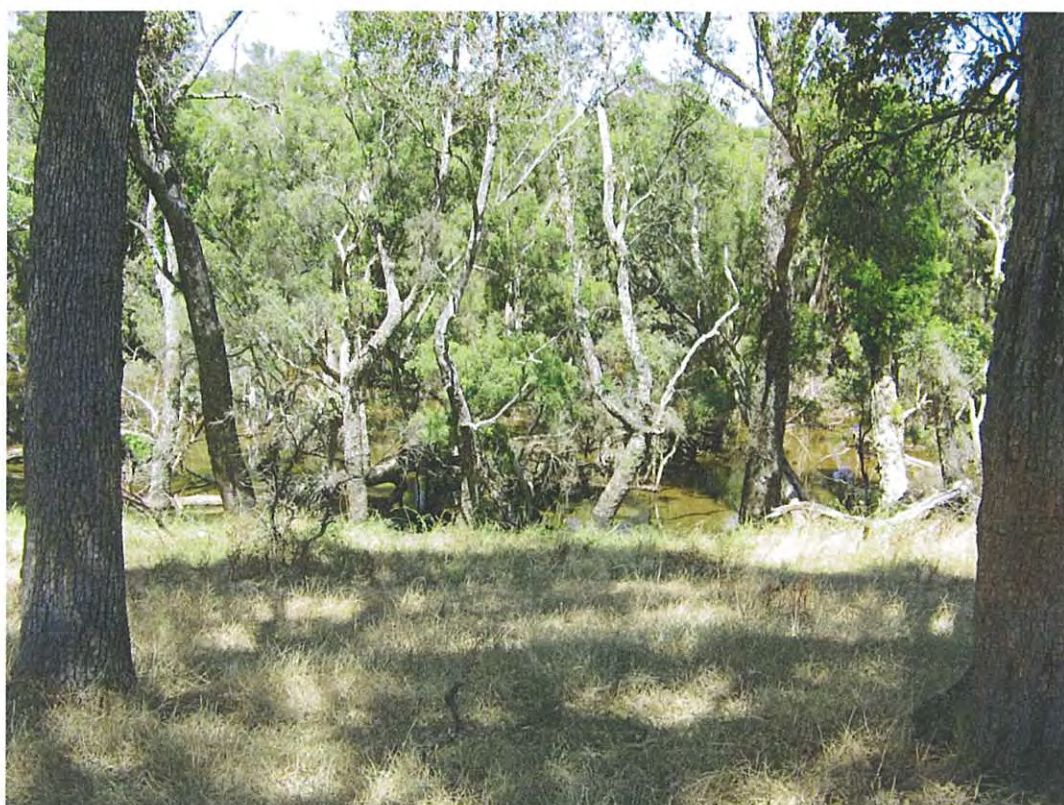
Plate 20 Condition of wetland #1869

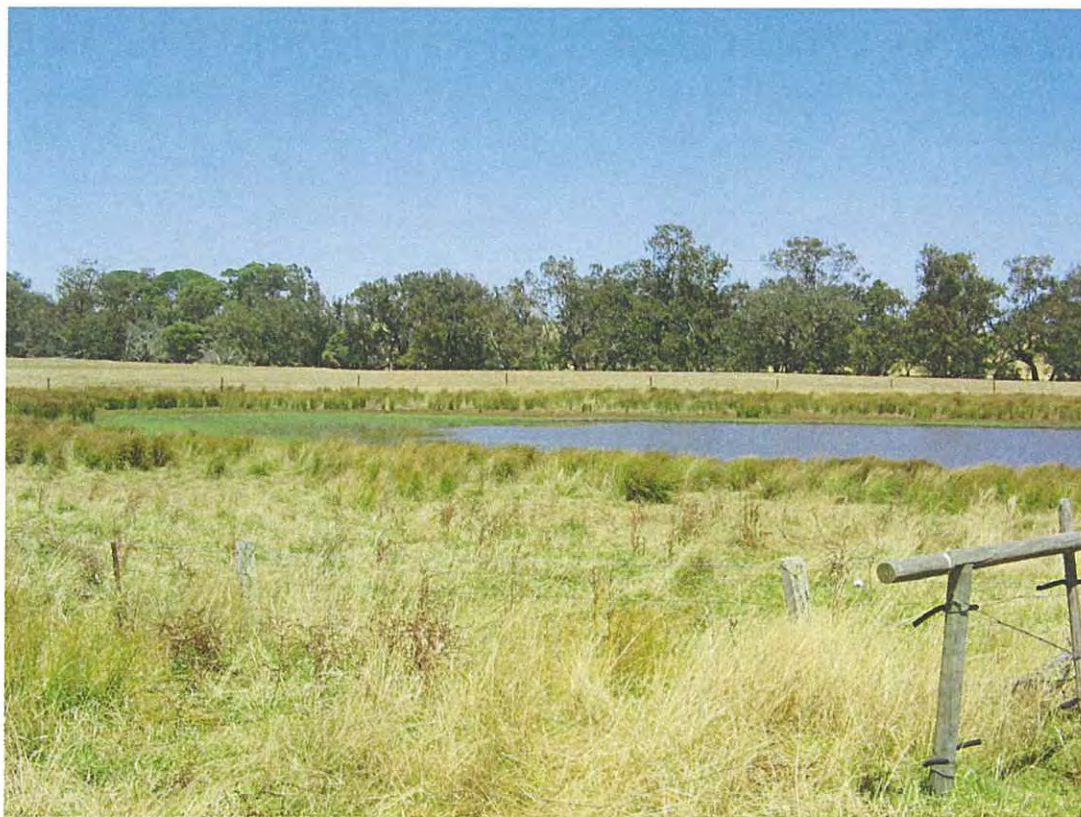
Plate 21      Condition of wetland #1718

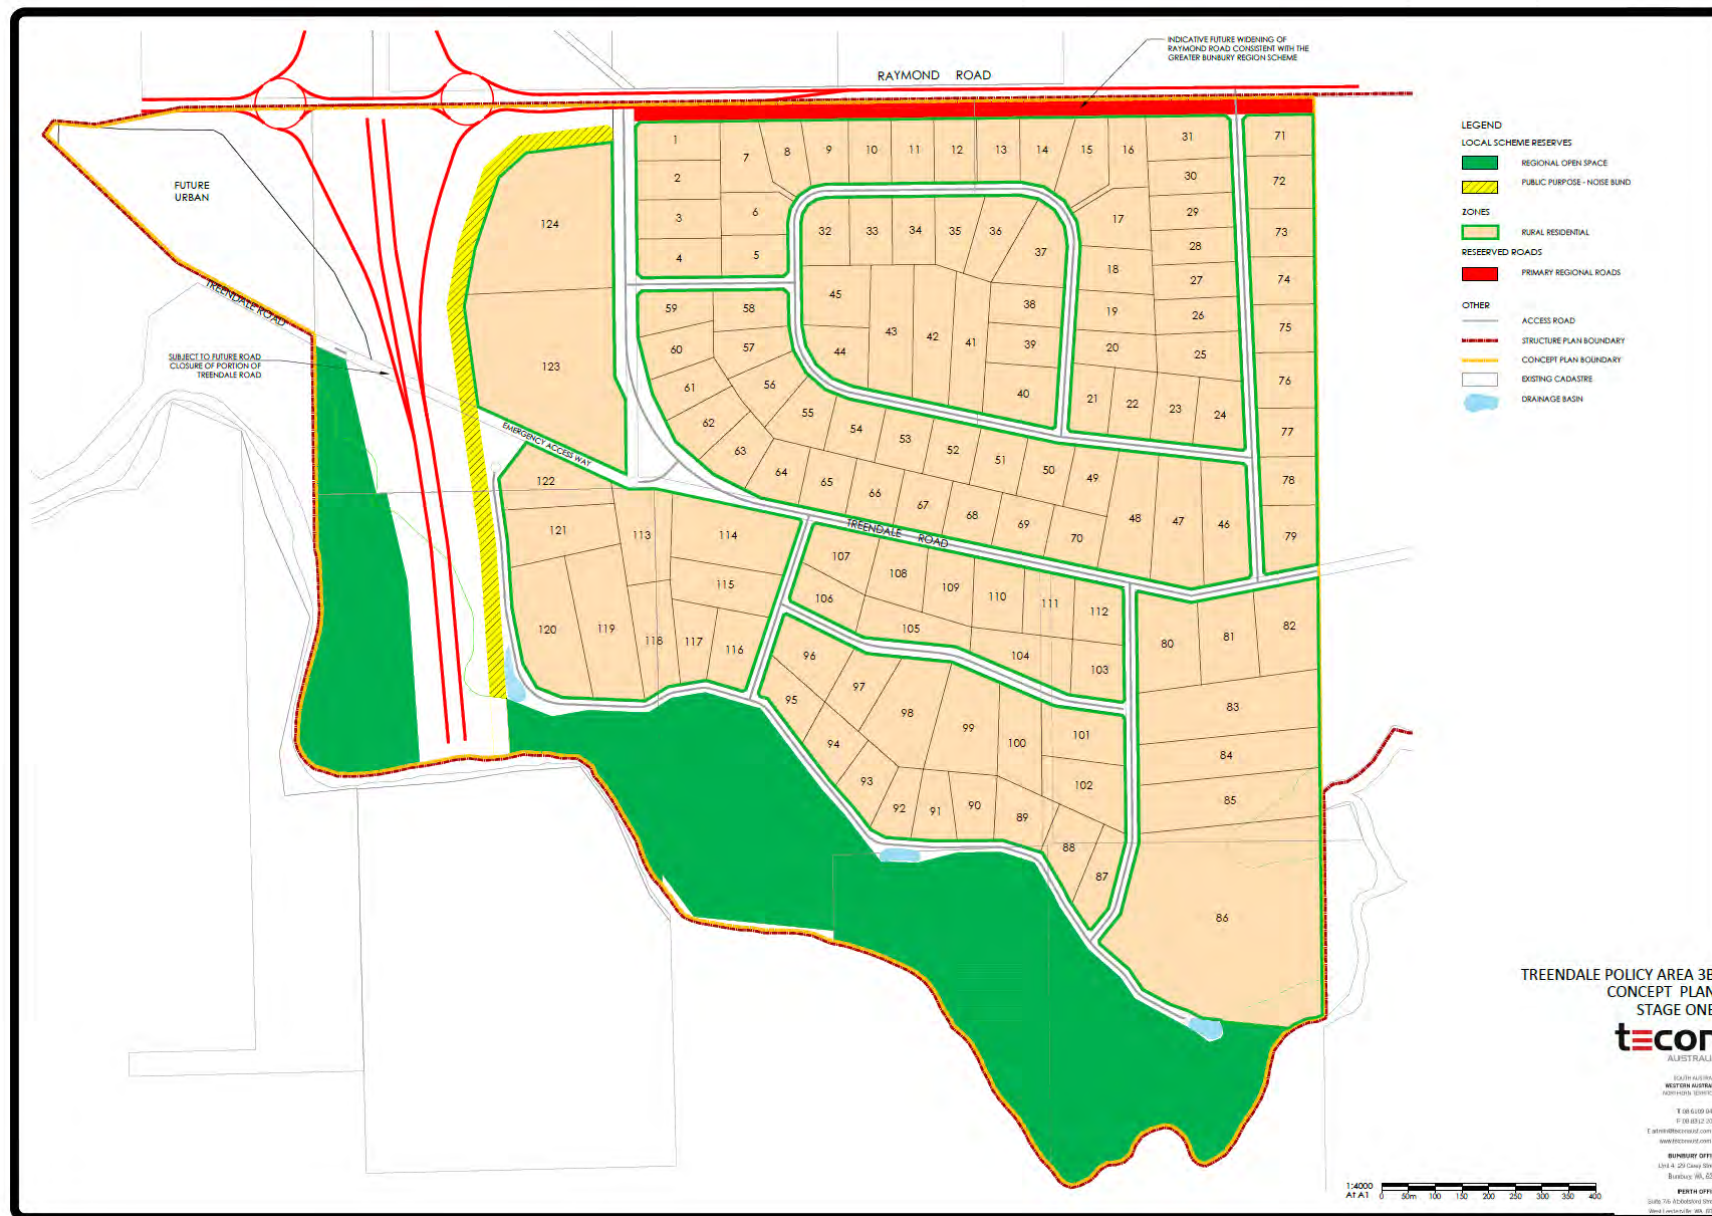
Figure 2: Subdivision concept plan

The Amended Structure Plan will provide the framework for the coordinated provision and arrangement of the land uses, subdivision and development. It will also inform the provision of a transport network, public open space, public utilities, development standards, community infrastructure and urban water management.

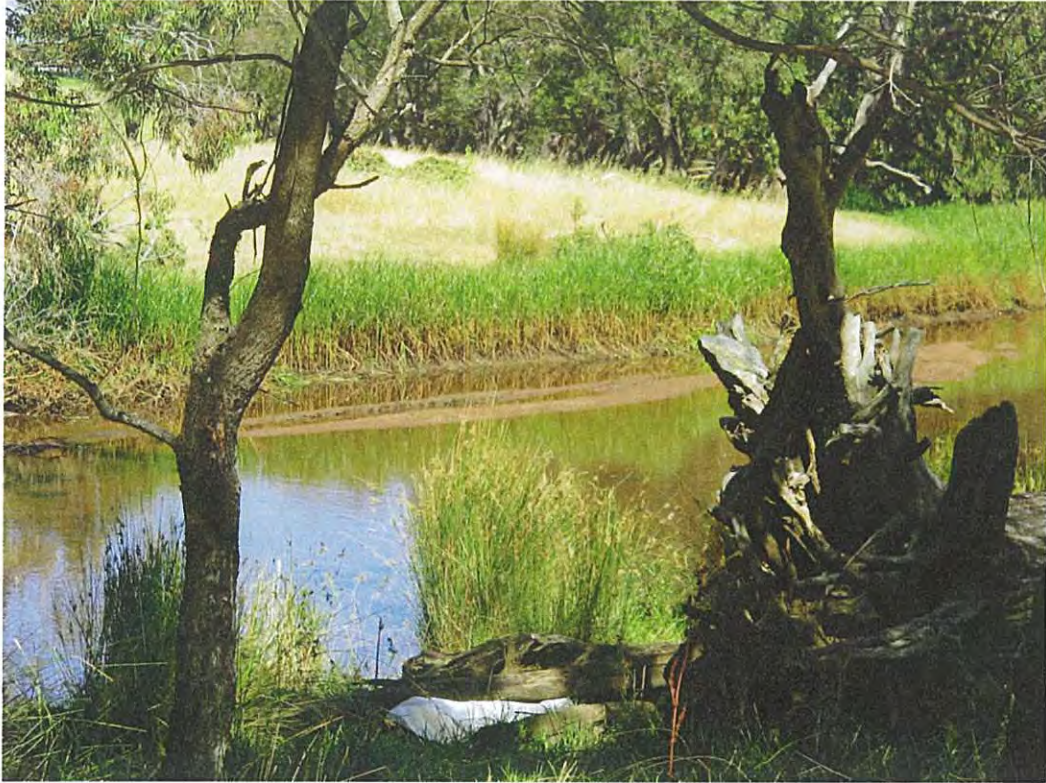
Plate 17      Condition of vegetation along Collie River (pt 1)

The floodplain of the Collie River within the study area is a part of a 347ha 'floodplain' that has been evaluated as MUW. This area has been mostly cleared for grazing, and remnant vegetation is limited to a thin strip of riparian vegetation along the Collie River. The typical condition of the 'floodplain' is shown in **Plates 17 and 18**. The entire floodplain area was observed to be currently utilised for grazing. Given the degraded condition of the floodplain area, it is considered that the MUW management category is appropriate. There is another approximately 3ha area located within the Collie River floodplain, that was not specifically identified within the Geomorphic Wetlands dataset, and this area appears to have characteristics consistent with a 'sumpland' wetland. This 'sumpland' wetland area is completely devoid of overstorey species, and has limited sedges and rushes that appear to have been impacted by stock grazing and trampling. The wetland does not retain any native vegetation buffer. The typical condition of the 'sumpland' is shown in **Plate 19**.

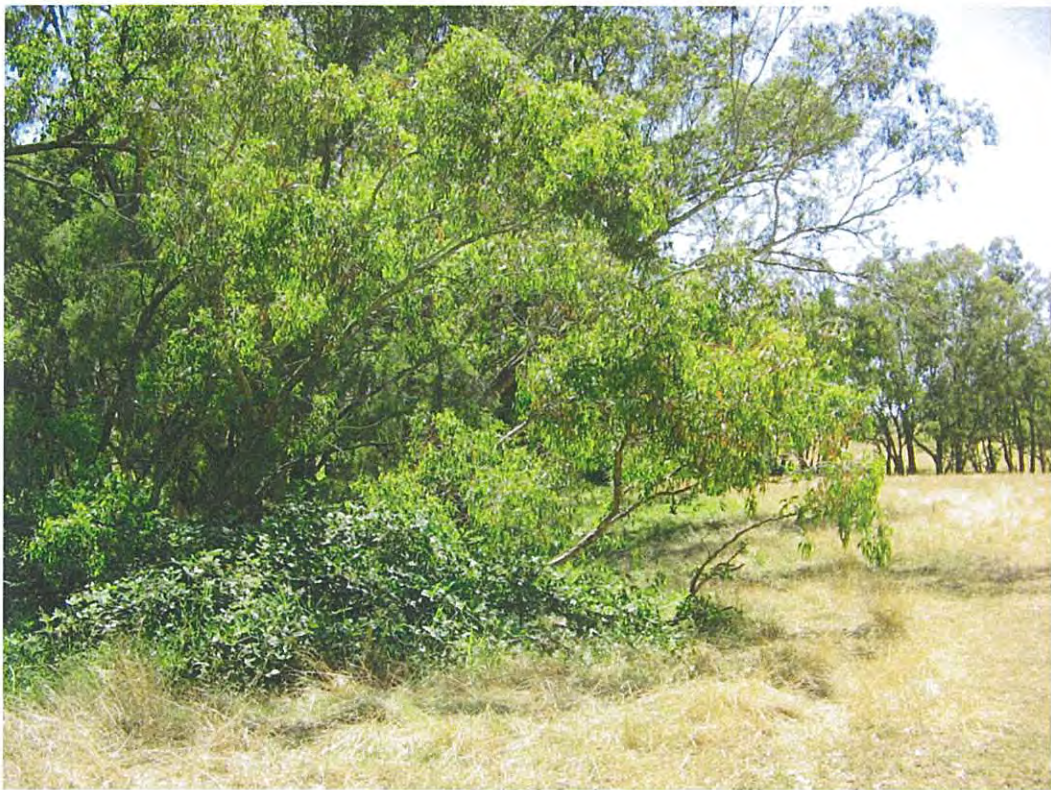
Plate 18      Condition of vegetation along Collie River (pt2)

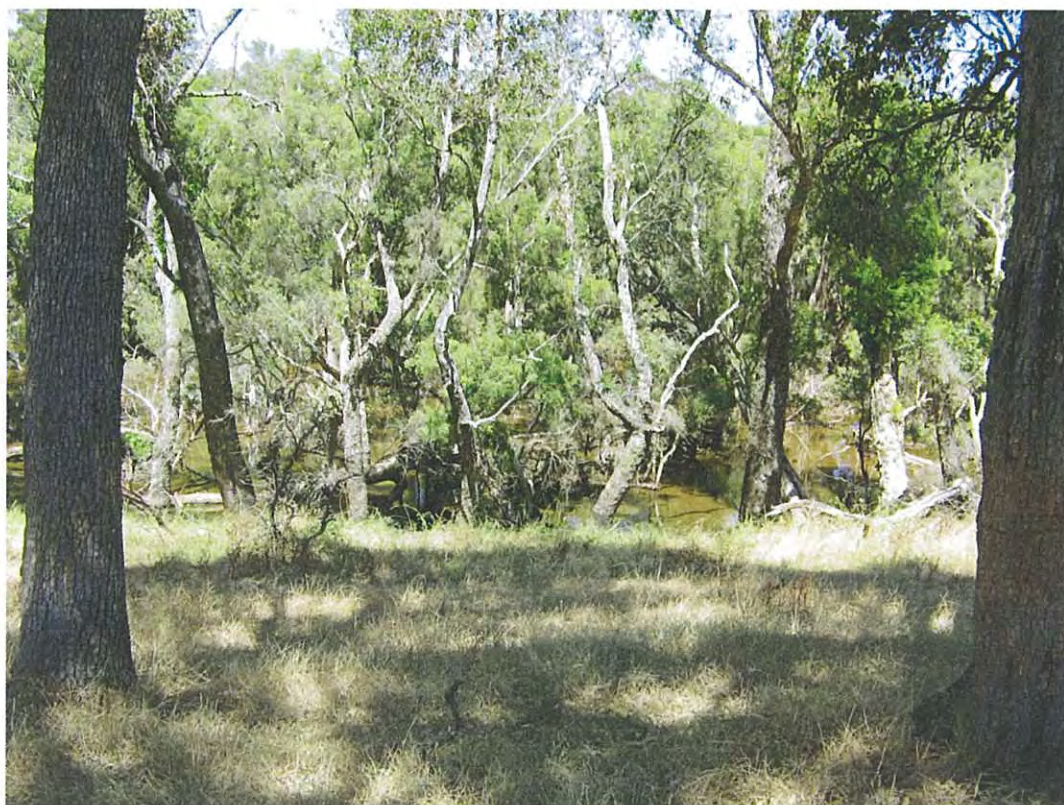
Plate 20 Condition of wetland #1869
