## Appendix C Site and Soil Evaluation

# LOT 51 RAYMOND ROAD, ROELANDS, WA

## SITE-AND-SOIL EVALUATION (SSE)

November 2025  
12130-G-R-001-1

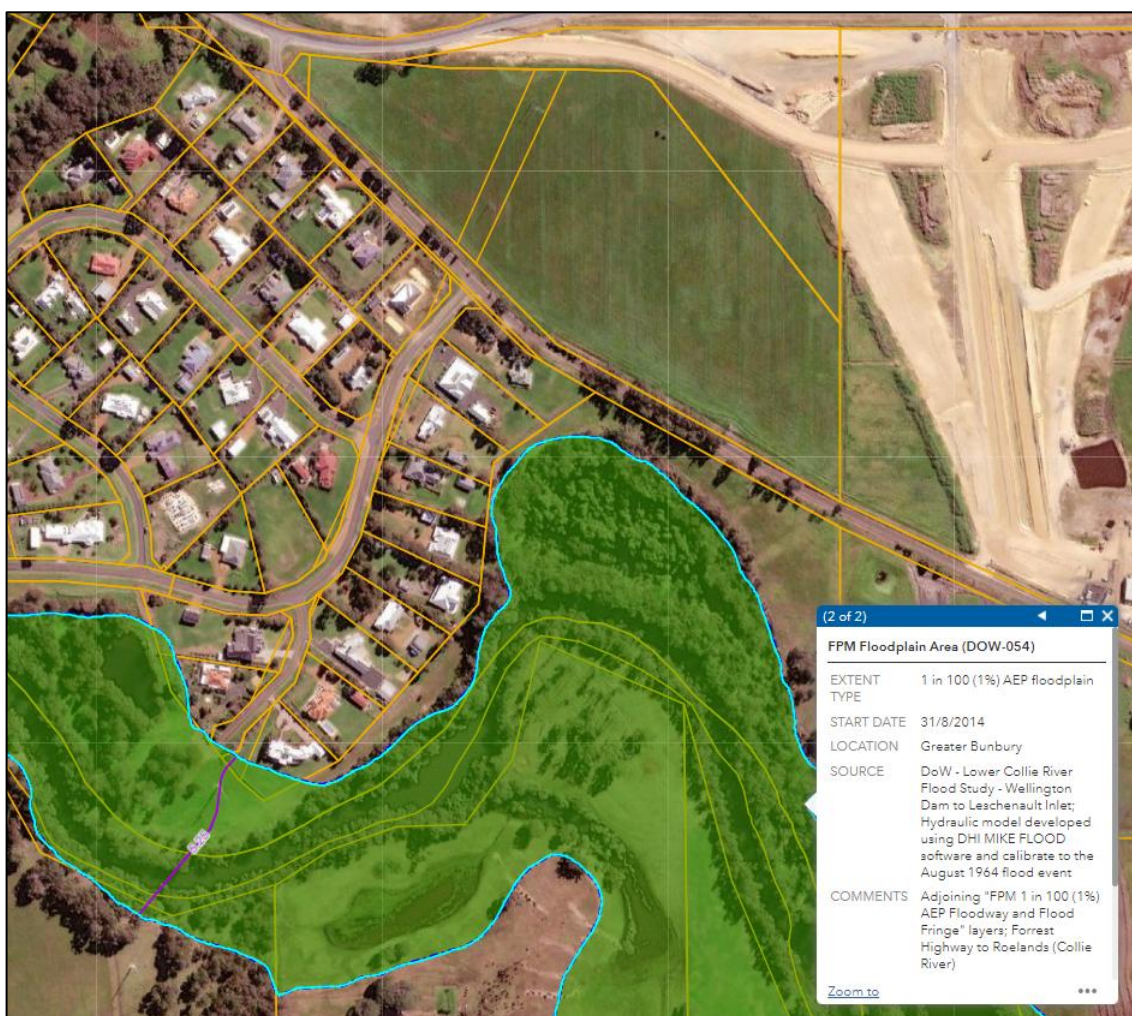
Figure 3. 1 in 100 (1%) AEP Floodplain Area.

- The site is not within the 1 in 100 (1%) Annual Exceedance Probability flood area (shown in Figure 3). However, the majority of the site is located within 1% AEP Floodplain Development Control Area (DWER); shown in Figure 4.

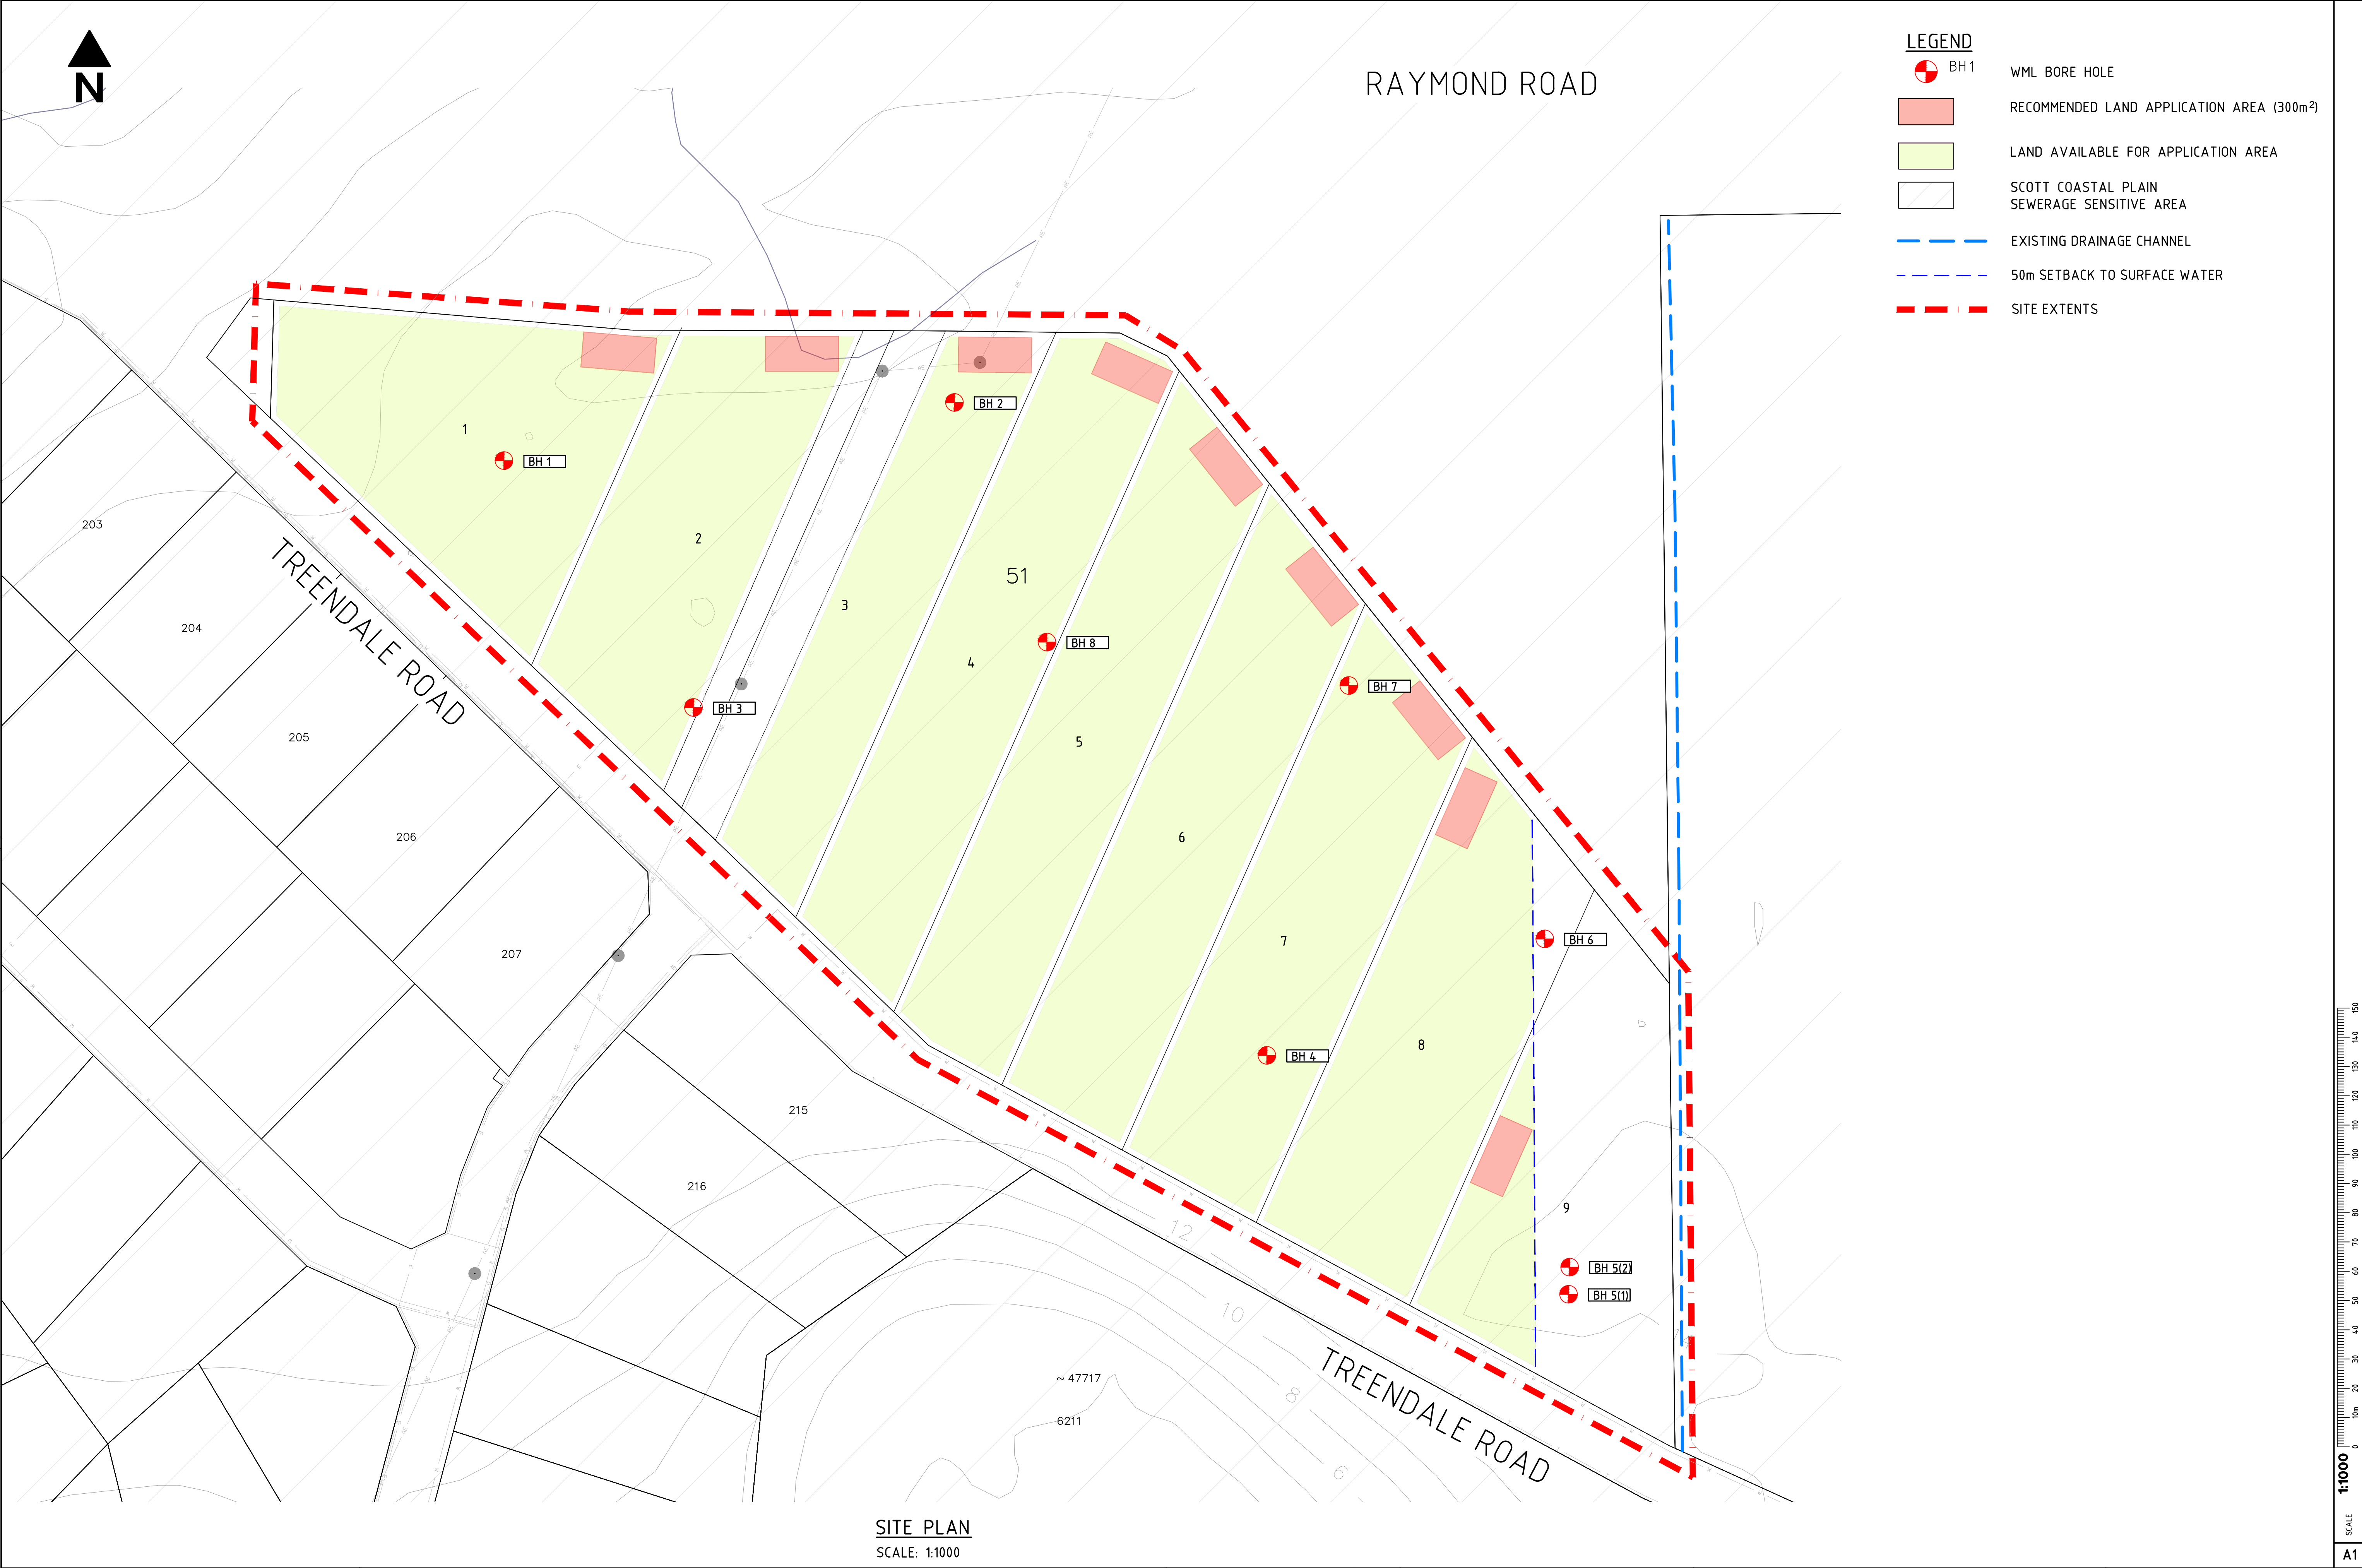
**WML**  
Consulting Engineers  
Civil | Geotechnical | Structural  
CONSULTANT DRAWING NUMBER 12130-G1-DG-002

- LEGEND**
- BH 1 WML BORE HOLE
  - RECOMMENDED LAND APPLICATION AREA (300m²)
  - LAND AVAILABLE FOR APPLICATION AREA
  - SCOTT COASTAL PLAIN SEWERAGE SENSITIVE AREA
  - EXISTING DRAINAGE CHANNEL
  - 50m SETBACK TO SURFACE WATER
  - SITE EXTENTS
