DIEBACK MANAGEMENT PLAN

Lot 1503 Harris Road, Myalup
Shire of Harvey

Prepared For: Gotam Pty Ltd

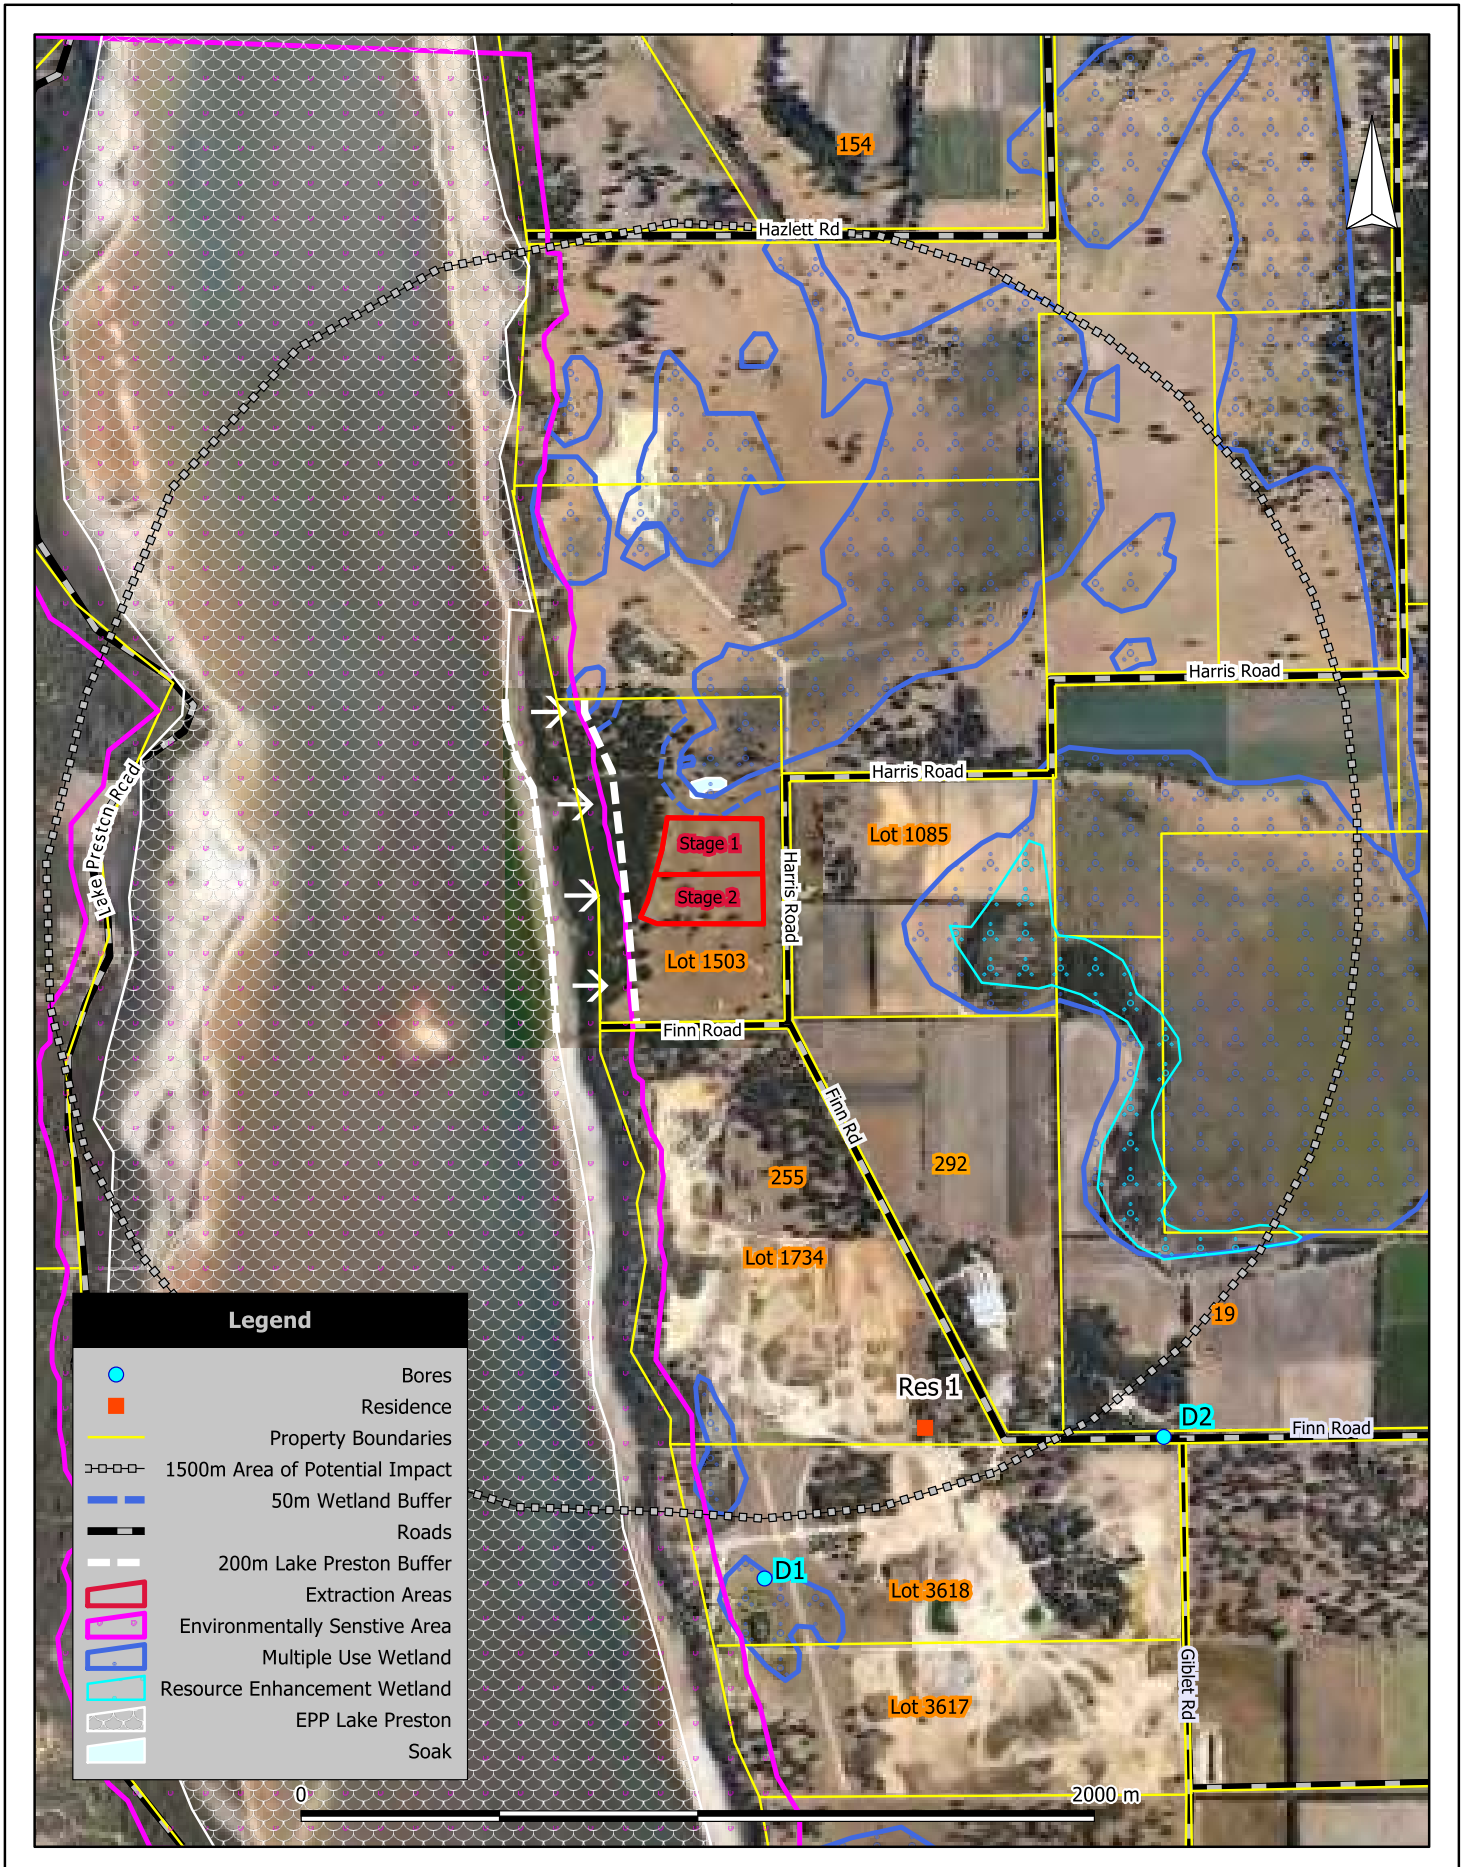
Site and Surrounds
Figure 1

The lot adjoins Lake Preston, about 2.5 km west of Forrest Highway and 9 km north of the Myalup town site (Figure 1).

The property borders Lake Preston and the Yalgorup National Park. Lake Preston and an area of vegetation surrounding it is classed as an Environmentally Sensitive Area (ESA) under Section 51B of the *Environmental Protection Act 1986* (LBP, 2015). The area within an ESA has high conservation value and cannot be cleared. This ESA includes a section of the western side of Lot 1503 but does not include any of the proposed extraction area (Figure 1).

- Extraction of sand and then limestone from the site.
- Topsoil and overburden will be stockpiled separately within the extraction license area, with stockpiles no higher than five meters.
- Within the active area a bulldozer will rip, blade and crush material with its tracks before pushing it to a stockpile.
- Screening will be conducted when necessary throughout the year.
- Excavation will proceed until a level of 1.250 m AHD has been reached in the east of the pit, on a gentle gradient toward the west of the pit, where excavation will cease at 0.96 m AHD.
- Trucks will enter the pit via Harris Road to be loaded from the stockpiles by a front-end loader (Figure 1).
- Rehabilitation of the site to pasture grasses after placement of 200 mm of topsoil.

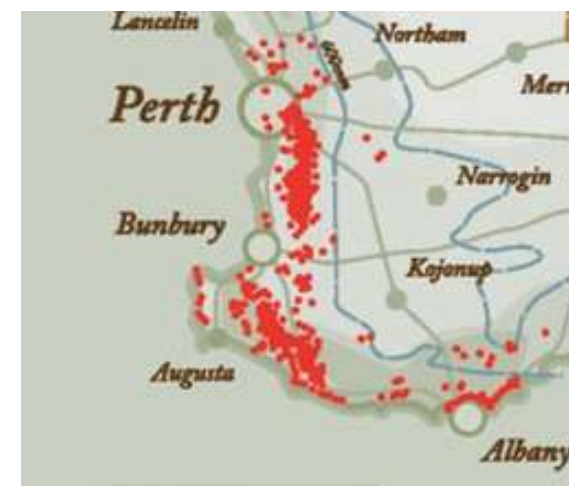
Below are areas with Dieback in the South West of Western Australia

A conservative estimate placed 15–20% of the Jarrah forest, around 60% of the Stirling Range shrubland and Banksia/Mallee woodland, and roughly 70% of the the Shannon and D'Entrecasteaux National Parks as infested.
